ANL/ET/CP-103132

To be presented at the 10th International Conference on Fracture (ICF-10), Dec. 3-7, 2001, Honolulu.

ANALYSIS AND TESTING OF RUPTURE OF STEAM GENERATOR TUBING WITH FLAWS*

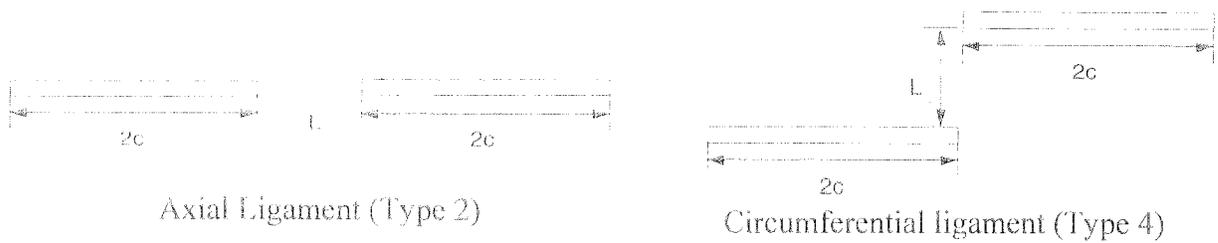
Figure 1: Type 2 and type 4 configurations of notches tested at ANL.

As a first step toward understanding the behavior of more complex cracks, tests were conducted on 22-mm (0.875 in.)-dia, 1.27-mm (0.05 in.)-wall thickness Alloy 600 tubes with two part-throughwall axial rectangular notches. The yield and ultimate tensile strengths of the tube material at room temperature are 300 MPa (43 ksi) and 675 MPa (98 ksi), respectively. Two different configurations of axial notches were tested (Figure 1). Each notch was either 6 mm (0.25 in.) or 13 mm (0.5 in.) long and 80% deep with a ligament width of either 0.25, 1.27, or 2.54 mm (0.01, 0.05, or 0.1 in.). Pressure tests were conducted at room temperature in two stages. In stage 1, the specimens were tested without a bladder until ligament rupture occurred and the pump could not keep up with the leak rate. In stage 2, a bladder and brass foil were inserted in a few of the specimens to cover the notches, and the specimens were pressurized until unstable burst occurred. Two tests with initially 100% deep notches (without bladder) were conducted in a high-flow-rate blowdown test facility. During stage 1 testing, the pressure was increased to the maximum limit of the facility. One of the two tests was conducted at 282°C with high-temperature pressurized water. A summary of the test results is given in Table 1 where, unless otherwise noted, all notches are 80% deep and tested at room temperature. After stage 1 testing, all of the axial ligaments in type 2 specimens were ruptured while all of the 2.54 mm (0.1 in.) ligaments in type 4 specimens survived. On the other hand, the 1.27 mm (0.05 in.) circumferential ligament of type 4 specimens ruptured during stage 1 testing with notch lengths of 12.7 mm (0.5 in.) but

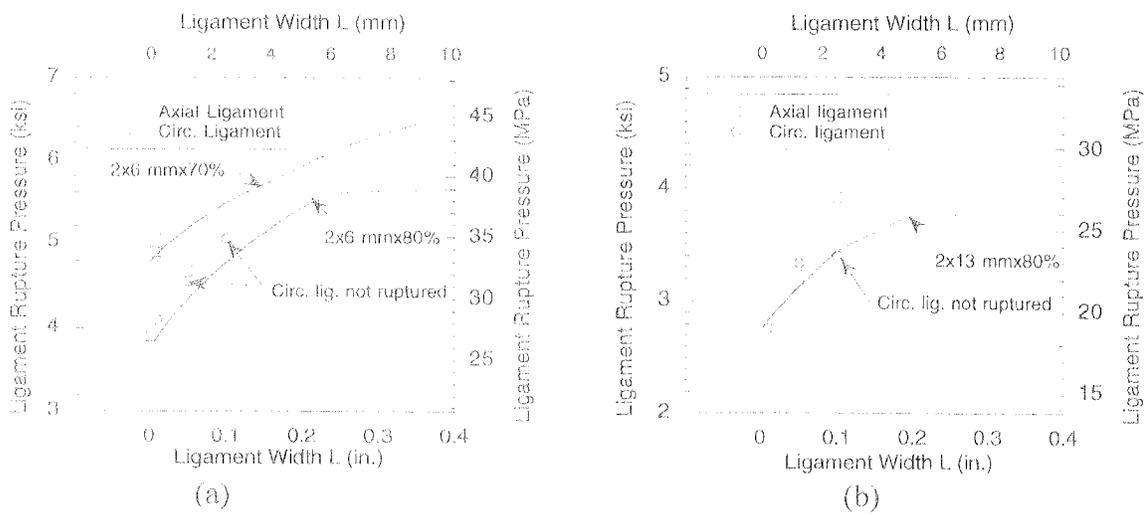
Figure 2: Predicted (lines) vs. observed (symbols) rupture pressures for through-thickness notch tip ligaments for type 2 (axial ligament) and type 4 (circumferential ligament) specimens with (a) two 6 mm notches and (b) two 13 mm notches.

A simple empirical method for predicting rupture pressure of a through-thickness notch tip ligament is based on defining an equivalent rectangular crack whose depth is obtained by equating the total area of the two notches to that of a single rectangular notch of the same total length. Predicted vs. observed ligament rupture pressures for type 2 and type 4 specimens tested at room temperature are shown in Figures 2a-b. Except for a single type 2 specimen with two 13-mm (0.5 in.)-long notches, the observed rupture pressures of through-thickness notch tip ligaments are close to those predicted by the equivalent rectangular crack method. Note that the method predicts a minimum ligament width beyond which the two notches behave as two independent notches. However, the method cannot predict the rupture pressure of the axial or circumferential ligament separating the two notches. The tests showed that although the axial ligaments for all type 2 specimens ruptured at the final pressure in stage 1, some of the circumferential ligaments of type 4 specimens survived. In cases where the ligament between the notches ruptured after stage 1 testing (e.g., Figure 3a), the final stage 2 unstable burst pressure can generally be predicted quite well by Eq. 1 for single cracks. In other cases (e.g., Figure 3b), the specimen is left with two throughwall notches with a ligament after stage 1 loading.

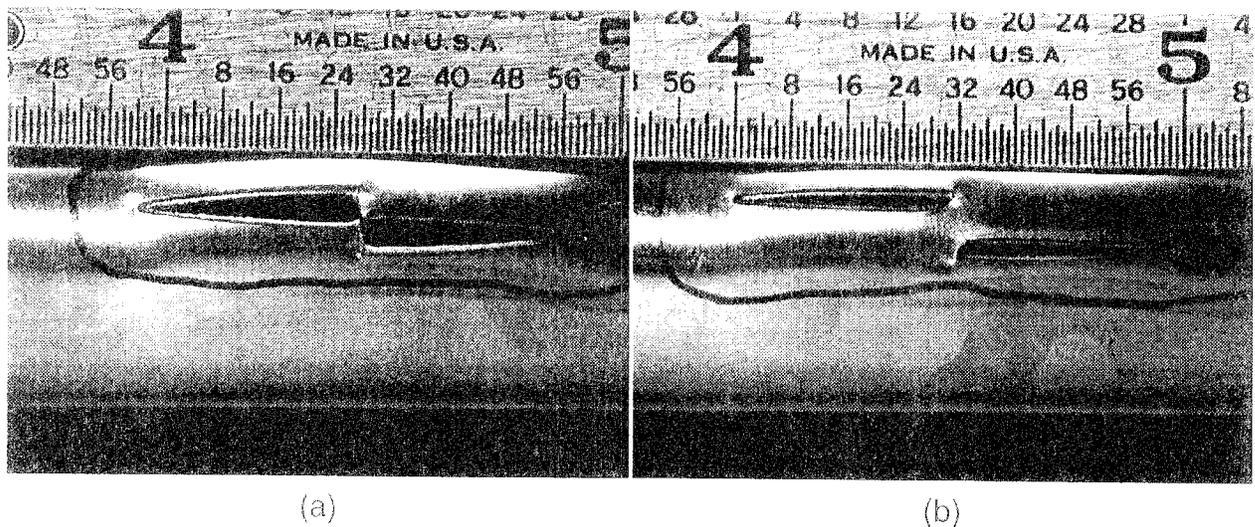
Figure 3: Post-test (stage 1) photos of flawed tubes with two 80% deep, 13-mm (0.5 in.)-long notches separated by a (a) 1.27-mm (0.05 in.)-wide and a (b) 2.54-mm (0.1 in.)-wide ligament.

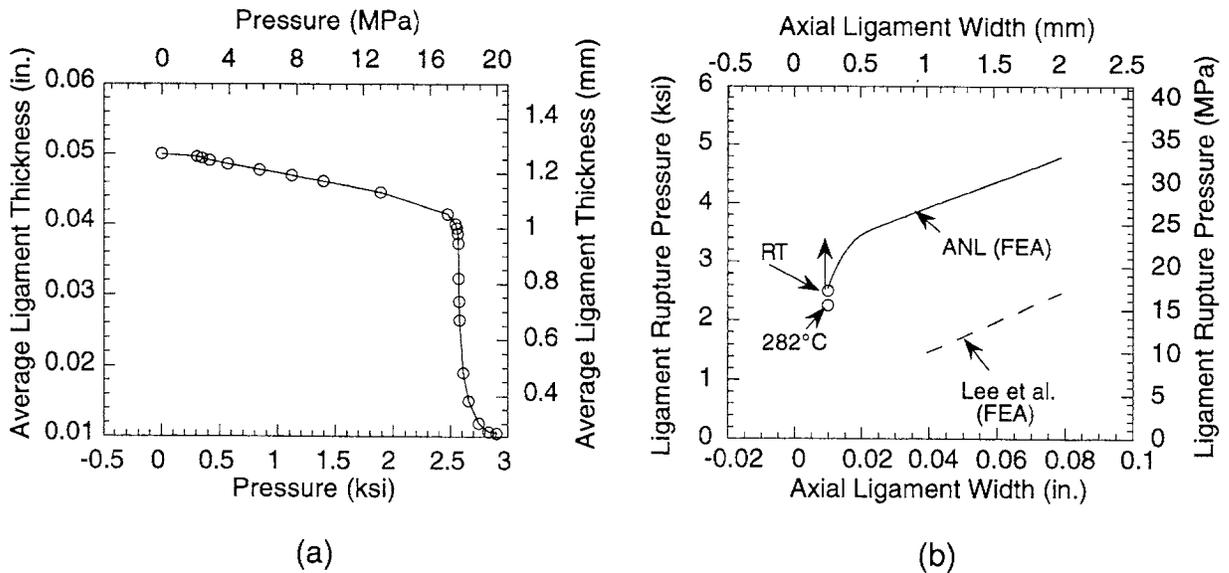
Figure 4: Results from FEA showing (a) variation of average axial ligament thickness with pressure for type 2 specimen with two 6-mm-long throughwall cracks separated by 0.25-mm-wide ligament, and (b) variation of ligament rupture pressure with axial ligament width for specimen with two 6-mm-long throughwall cracks. Symbols represent results from tests, with up arrow indicating no rupture of ligament. Dashed line is obtained from Ref. 13.

Nonlinear finite-element analyses with shell elements (ABAQUS) were performed for a type 2 specimen with two 100% deep, 6-mm (0.25 in.)-long notches separated by an axial ligament of varying width. A plot of the variation of average ligament thickness with pressure for a 0.25-mm (0.01 in.)-wide ligament is shown in Figure 4a. The rapid decrease in thickness at a pressure of 17 MPa (2.5 ksi) indicates onset of a necking-like behavior. A corresponding test (T24) conducted at room temperature did not experience ligament rupture. However, the ligament of an identical specimen (T25) tested at 282°C did rupture at 15.5 MPa (2.25 ksi), indicating that the room-temperature test was close to ligament rupture (flow stress at 282°C is 10% lower than at room temperature). Variation of the calculated ligament rupture pressure with ligament width is shown in Figure 4b, which also includes ligament rupture pressures calculated by Lee et al. [13] with a flow stress criterion (i.e., average ligament stress = flow stress = average of yield and ultimate tensile strengths). It is evident that a rupture criterion based on flow stress significantly underestimates the ligament rupture pressure because failure of the ligament occurs by necking.

Results from a similar analysis for a type 4 specimen (Figure 5a) shows a more gradual reduction in average ligament thickness with pressure than shown in Figure 4a for a type 2 specimen. Because the calculated ligament rupture pressure (38 MPa) is greater than the unstable burst pressure of the resulting 13-mm (0.5 in.)-long throughwall crack, the specimen is predicted to burst unstably at 38 MPa, which agrees with the reported stage 2 burst pressure of specimen OM159 (Table 1). Note that in contrast to type 2 specimen, the ligament in the type 4 specimen is subjected to high shearing strain (Figure 5b).

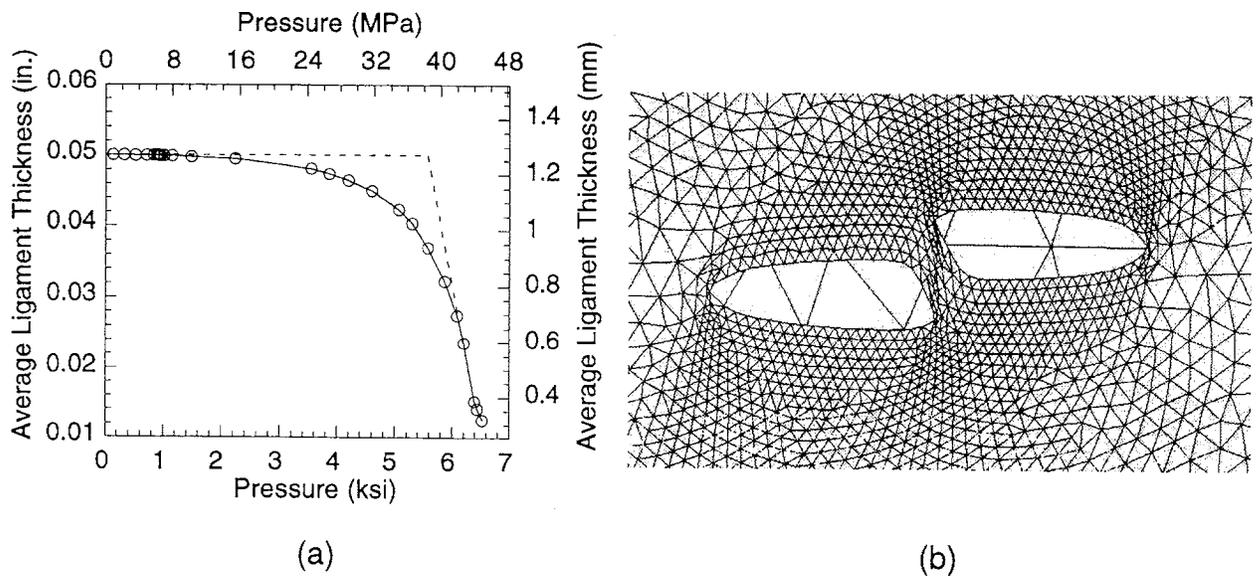
Figure 5: Results from FEA showing (a) variation of average axial ligament thickness with pressure and (b) deformed shape of type 4 specimen with two 6-mm-long throughwall cracks separated by 2.54-mm-wide ligament.
