ICONE  
Conference Paper

**ICONE10-22485**

**COMPLETION OF EXPERIMENTAL BREEDER REACTOR-II SODIUM PROCESSING  
AT ARGONNE NATIONAL LABORATORY**

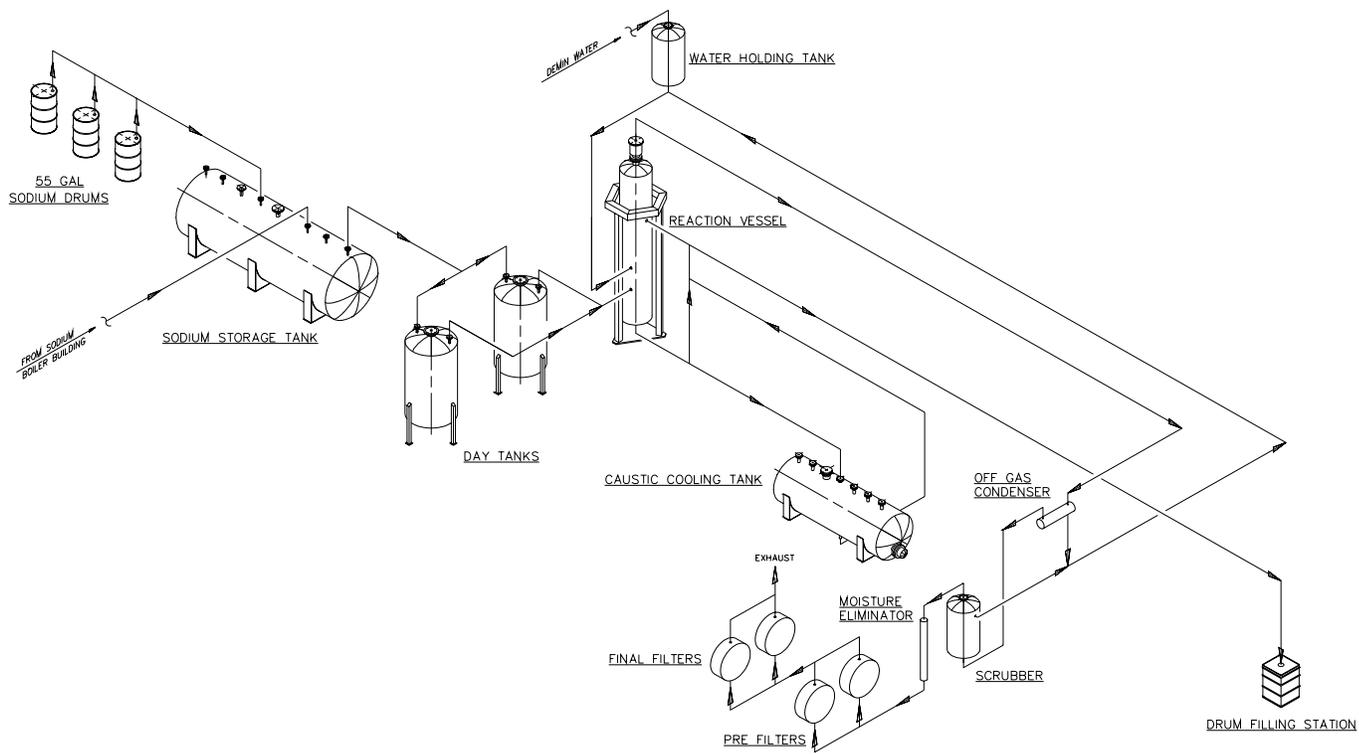
Figure 1. Sodium Process Facility Flow Diagram

The SPF Flow Diagram is shown in Fig. 1. The process begins with molten sodium at 120°C (250°F) being introduced into the sodium storage tank at the SPF. Sodium is available from two sources, although electrical interlocks only allow one source to be used at a time. The first source is the 210 liter (55 gallon) Fermi-1 primary sodium barrels. The barrels are moved to the barrel melt and drain room where they are placed into the melting stations. There are two manifolds each consisting of four barrel melting stations. Once the barrels are in place, they are opened, and the nitrogen purge lines, heaters, and insulation blankets are attached. The barrels are heated to 120EC (250EF) to melt the sodium. Dip tubes are inserted through the top of the barrel and the molten sodium is vacuum transferred to the 19 m<sup>3</sup> (5000 gallon) carbon steel sodium storage tank. The melting stations have a mechanism to tilt the barrels to maximize the removal of sodium.

From the sodium storage tank, molten sodium is transferred to one of two carbon steel day tanks by pressurizing the sodium storage tank. Each of the day tanks holds 3 m<sup>3</sup> (730 gallons) of sodium, which allows for approximately one day's operation based on design throughput. By using the day tanks, the sodium storage tank is free to receive sodium from the barrel melt and drain system or the transfer line.

Prior to reacting the sodium, the nickel reaction vessel is charged with 50 wt% sodium hydroxide from the caustic cooling tank. A day tank is pressurized to flow sodium through a sodium injection nozzle, into the 50 wt% sodium hydroxide solution in the reaction vessel. Nitrogen is injected into the process through an annulus around the sodium injection nozzle to atomize the sodium and move the chemical reaction into the working fluid toward the center of the reaction vessel. As sodium is injected into the reaction vessel, the 50 wt% sodium hydroxide is concentrated to 70 wt% by the sodium reaction and the evaporation of water. The sodium hydroxide solution in the reaction vessel is maintained at saturation (boiling) temperature, which is directly related to the sodium hydroxide concentration. Through a separate nozzle, water is injected into the reaction vessel to maintain the temperature at approximately 185EC (367EF) and the sodium hydroxide solution at approximately 70 wt%. The sodium hydroxide being generated in the reaction vessel is continuously circulated to maintain a homogenous solution.

The sodium reaction process creates gaseous hydrogen and steam which are removed by the off-gas system. Off-gas from the reaction vessel flows through a mesh demister, is cooled in a condenser to remove the water vapor, flows through a scrubber to remove any entrained sodium hydroxide vapors, flows through a moisture eliminator, and is filtered through pre-filters and high efficiency particulate air (HEPA) filters to remove any particulate contamination. The remaining gaseous nitrogen and hydrogen are discharged through a facility stack.

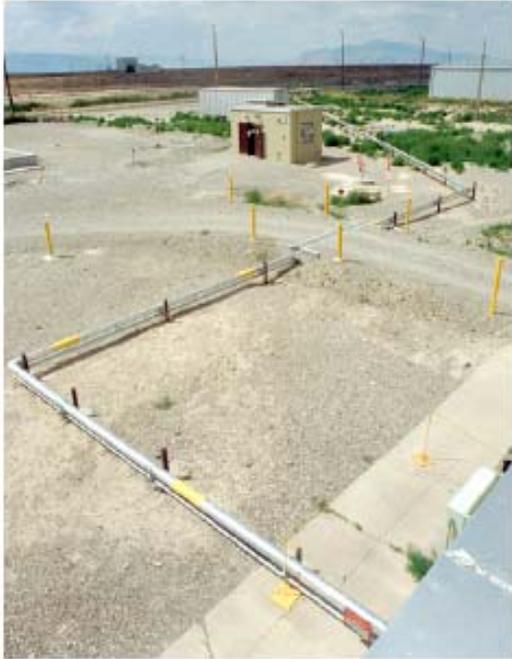
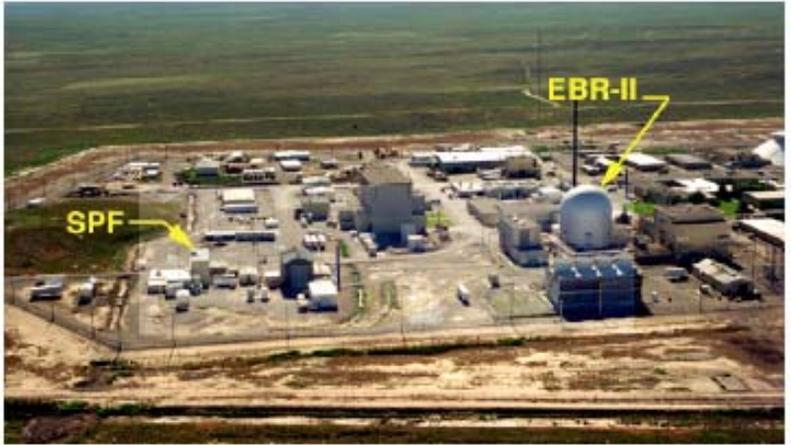
Figure 2. Transfer Line

The second source of sodium for the sodium storage tank is from the EBR-II by way of the sodium transfer line. A transfer line was built from the drain tank system in the EBR-II sodium boiler building to the SPF sodium storage tank as shown in Fig. 2. The transfer line is constructed of 4 cm (1½ inch) stainless steel pipe, approximately 250 m (820 feet) long. To allow surveillance during sodium transfer, the transfer line is located outside and above ground. It is also heat-traced and insulated to maintain sodium temperatures during transfer.
