# Environmentally Assisted Cracking in Light Water Reactors

Annual Report  
January—December 2003

Prepared by  
B. Alexandreanu, O. K. Chopra, H. M. Chung,  
E. E. Gruber, and W. J. Shack

Argonne National Laboratory  
9700 South Cass Avenue  
Argonne, IL 60439

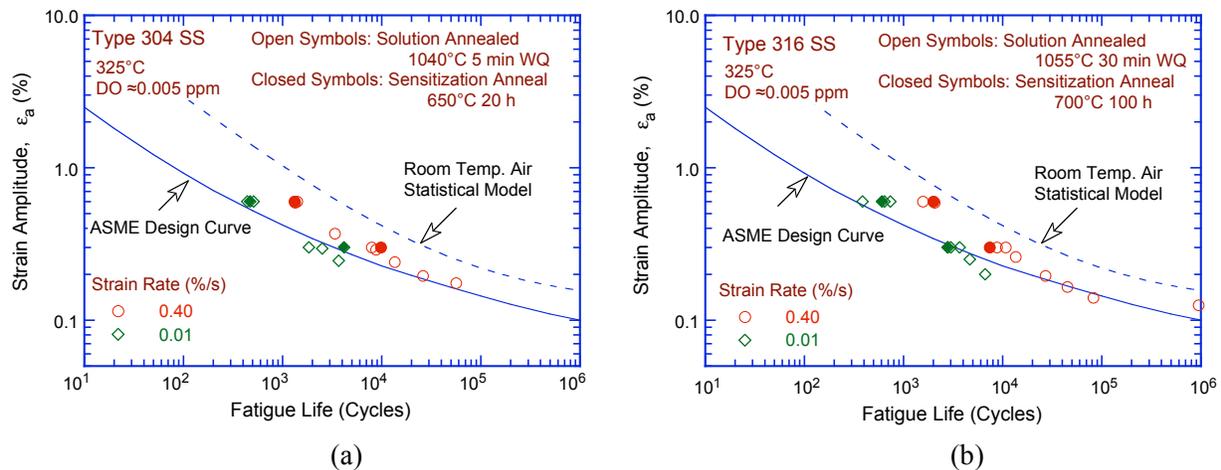
Figure 5. Effect of sensitization annealing on fatigue life of Type (a) 304 and (b) 316 stainless steel in low–DO water at 325°C (Refs. 10,11). WQ = water quenched.

These results are consistent with the data obtained at Mitsubishi Heavy Industries, Ltd. (MHI)<sup>10–12</sup> and Ishikawajima–Harima Heavy Industries Co. (IHI)<sup>13</sup> on solution–annealed and sensitized Type 304, 316, and 316NG SS (Figs. 5 and 6). For example, in low–DO (<0.005 ppm) water, environmental effects on the fatigue life of Type 304 and 316 SS are significant irrespective of material heat treatment (Fig. 5). In high–DO (8 ppm) water, the fatigue life of solution–annealed Type 304 SS is a factor of  $\approx 2$  longer than that of the sensitized steel (Fig. 6a). A sensitization anneal appears to have little or no effect on the fatigue life of Type 316NG SS in high–DO water at 288°C (Fig. 6b). Fatigue lives of solution–annealed and sensitized Type 316NG SS are comparable.

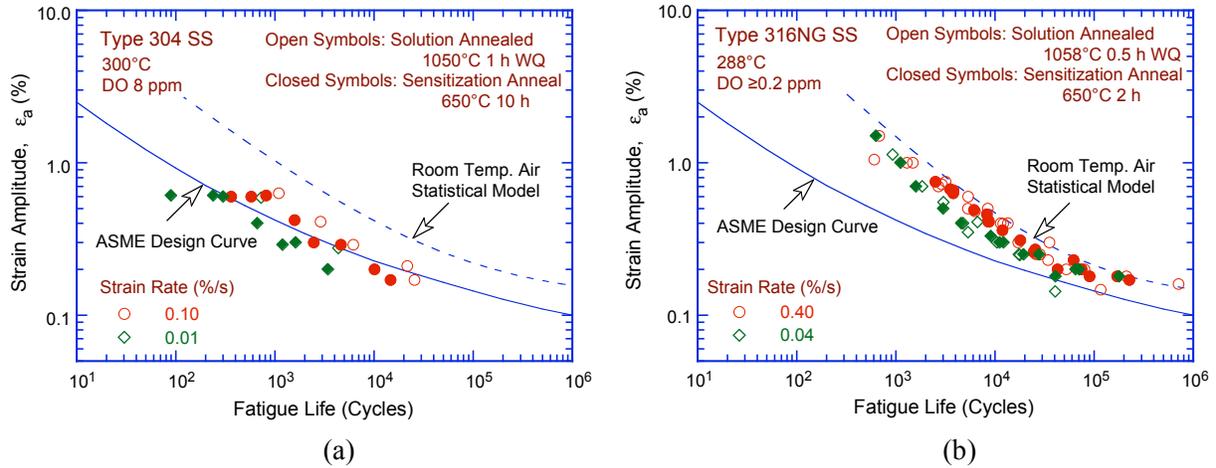
Figure 6. Effect of sensitization anneal on the fatigue lives of Type (a) 304 and (b) 316NG stainless steel in high-DO water (Refs. 12,13). WQ = water quenched.

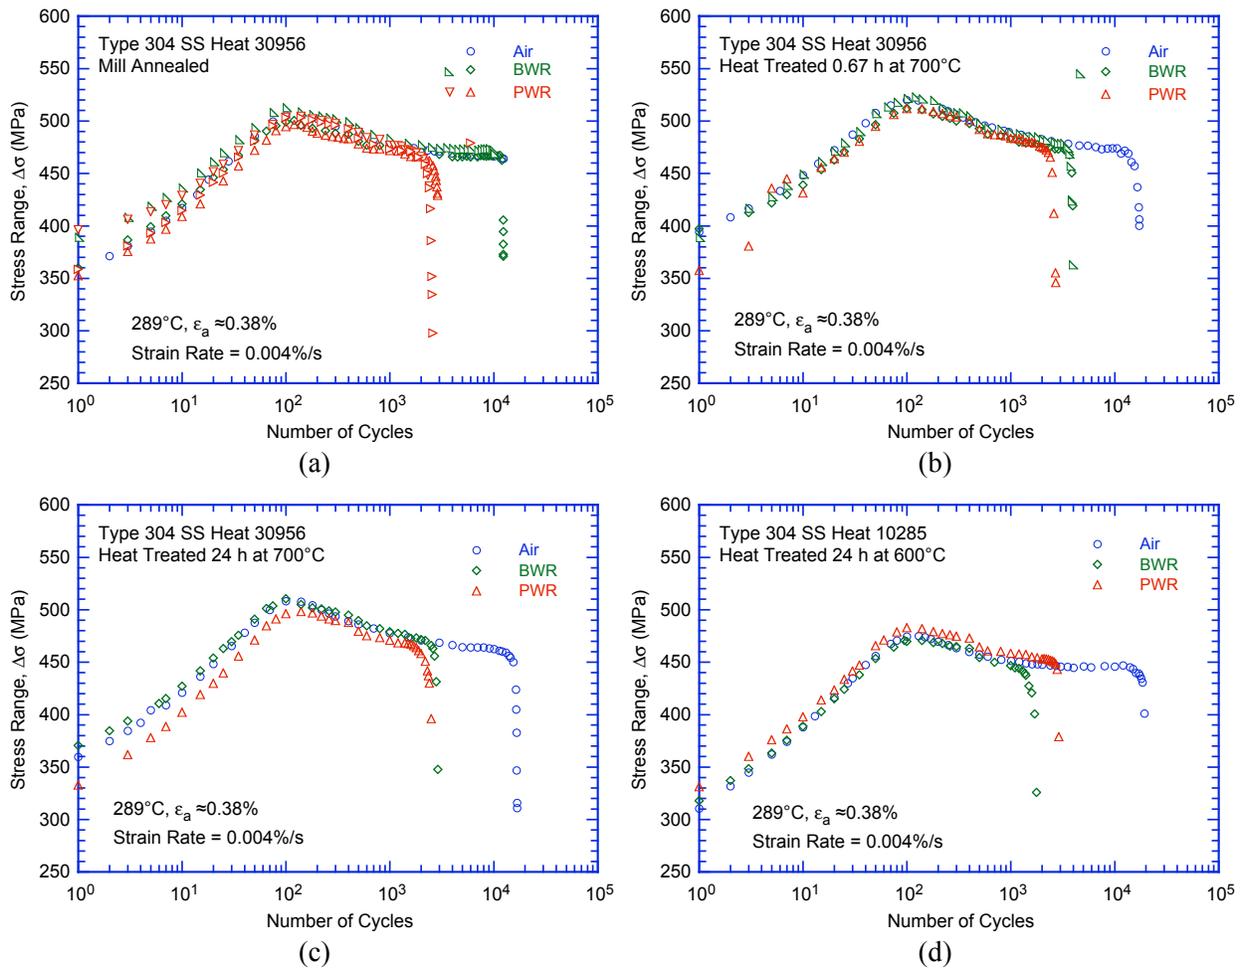
Figure 7. Cyclic stress response of Heat 30956: (a) MA, (b) MA + 0.67 h at 700°C, and (c) MA + 24 h at 700°C; and Heat 10285, (d) MA + 24 h at 600°C in air, BWR, and PWR environments at 289°C.

The cyclic stress response of the various materials in air, BWR, and PWR environments at 289°C is shown in Fig. 7. As expected, the cyclic strain–hardening behavior of Type 304 SS under various heat treatment conditions is identical; only the fatigue life varies in the environments.

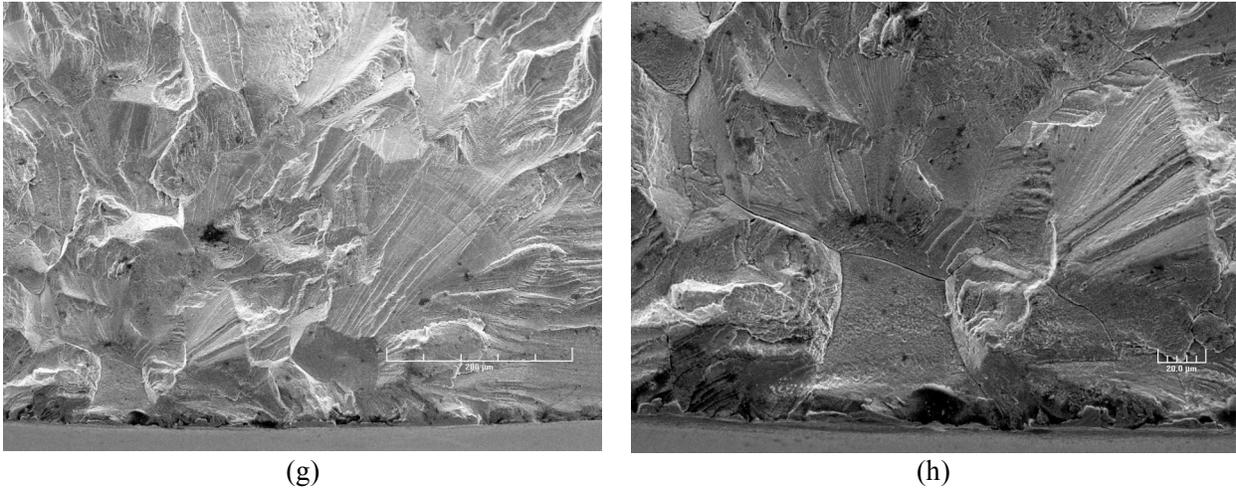
Figure 9. Photomicrographs showing sites of crack initiation on fracture surfaces of Type 304 SS specimens tested in simulated BWR environment: (a), (c), (e), (g) low magnification; (b), (d), (f), (h) high magnification.

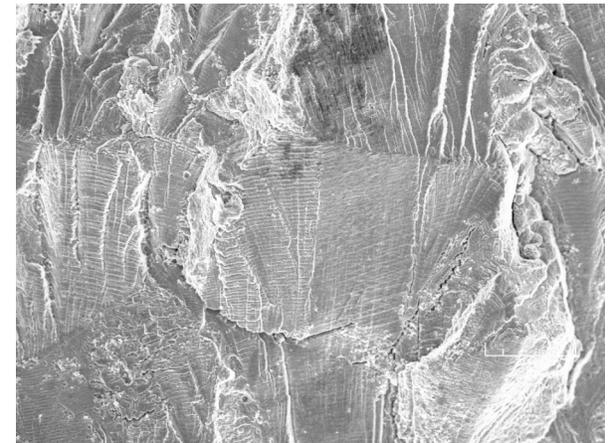
Figure 12. Photomicrographs showing striations at select locations on fracture surfaces of MA specimens of Heat 30956 heat-treated for 0.67 h at 700°C in air, BWR, and PWR environments: (a), (c), (e) low magnification; (b), (d), (f) high-magnification.

Fatigue striations normal to the crack advance direction were clearly visible beyond  $\approx 200\ \mu\text{m}$  on the fracture surfaces of all materials under all environmental conditions, as documented in Figs. 11-14. For example, for the MA Heat 30956 samples tested in BWR water (Fig. 11), striations were easily discernible on the facets irrespective of the steps, cleavage-like features, or river patterns. Similar striations were also observed on the fracture surface of MA Heat 30956 heat-treated 0.67 h at  $700^\circ\text{C}$  irrespective of the testing environment (Fig. 12). Striations were found on both the TG and IG facets of the samples tested under BWR conditions, or co-existing with the “river” patterns specific to the samples tested in the PWR environment. Evidence of extensive rubbing due to repeated contact between the two mating surfaces (Figs. 12a and b) was also found.

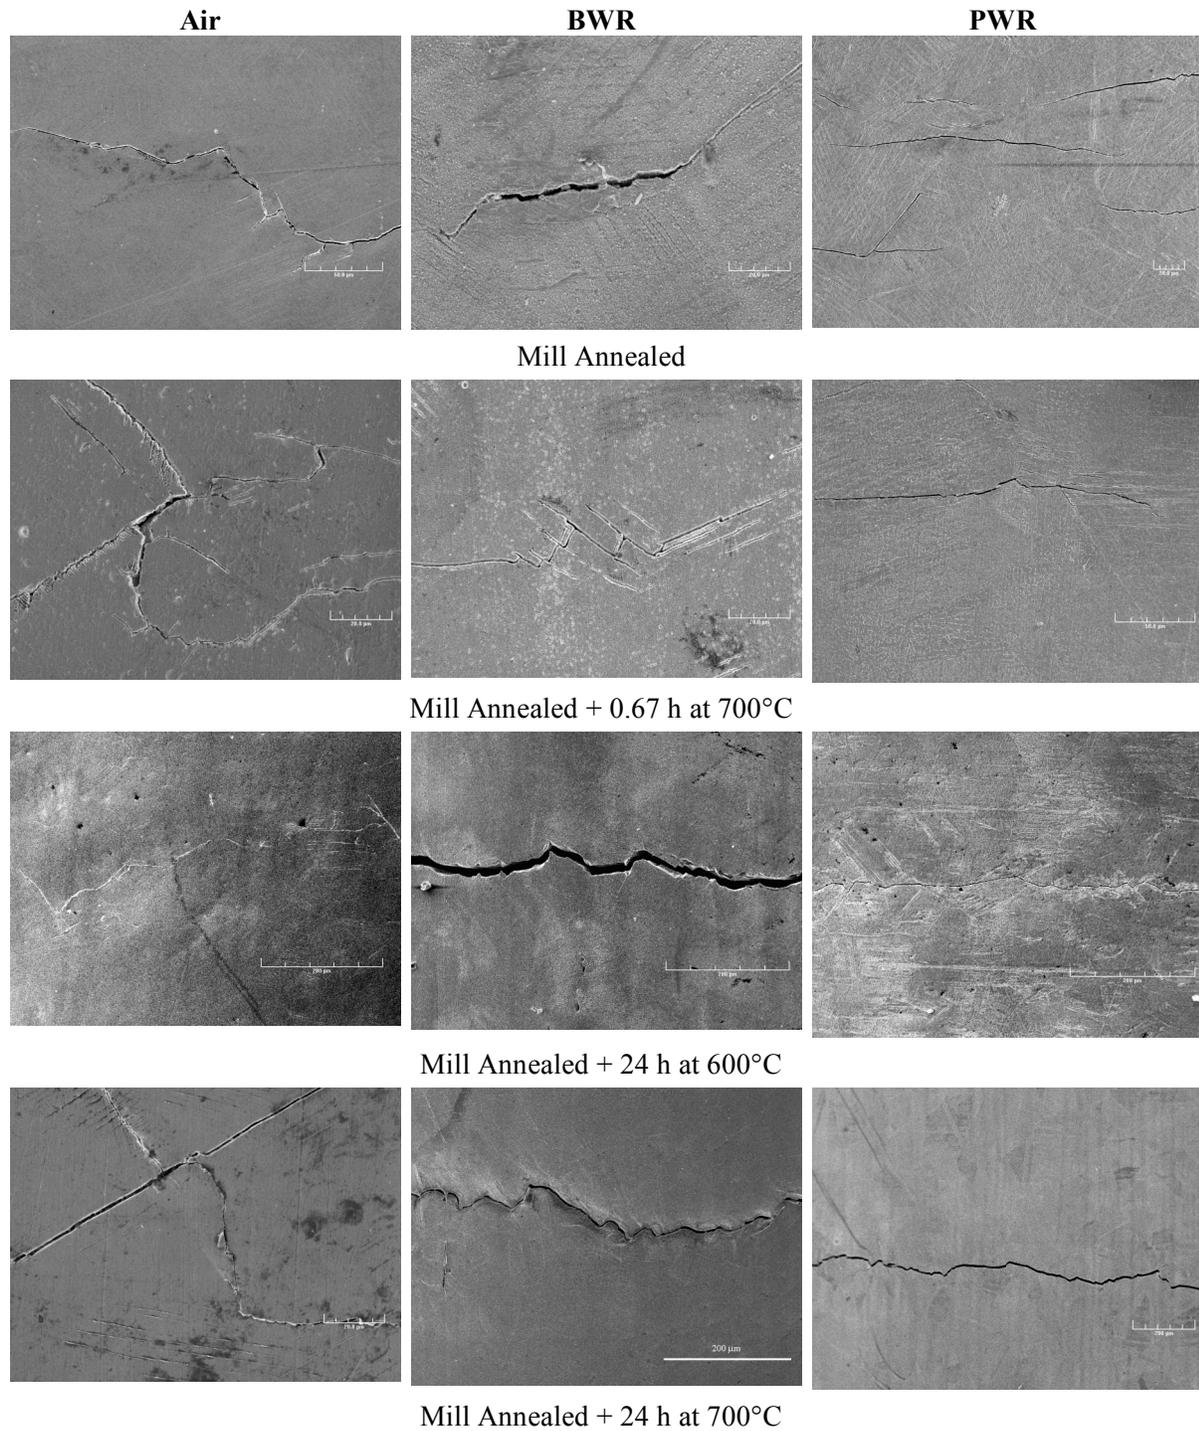
Photomicrographs of the crack morphology of Type 304 SS under all test and environmental conditions are presented in Fig. 15. In all cases, the tensile axis is vertical, parallel to the plane of each picture. In general, for air tests the cracks are more likely to be oblique, approaching 45° with respect to the tensile axis. By contrast, the cracks that form in either BWR or PWR environments tend to be perpendicular to the tensile axis.

Figure 15. Photomicrographs of the crack morphology of Type 304 SS under all test and environmental conditions.

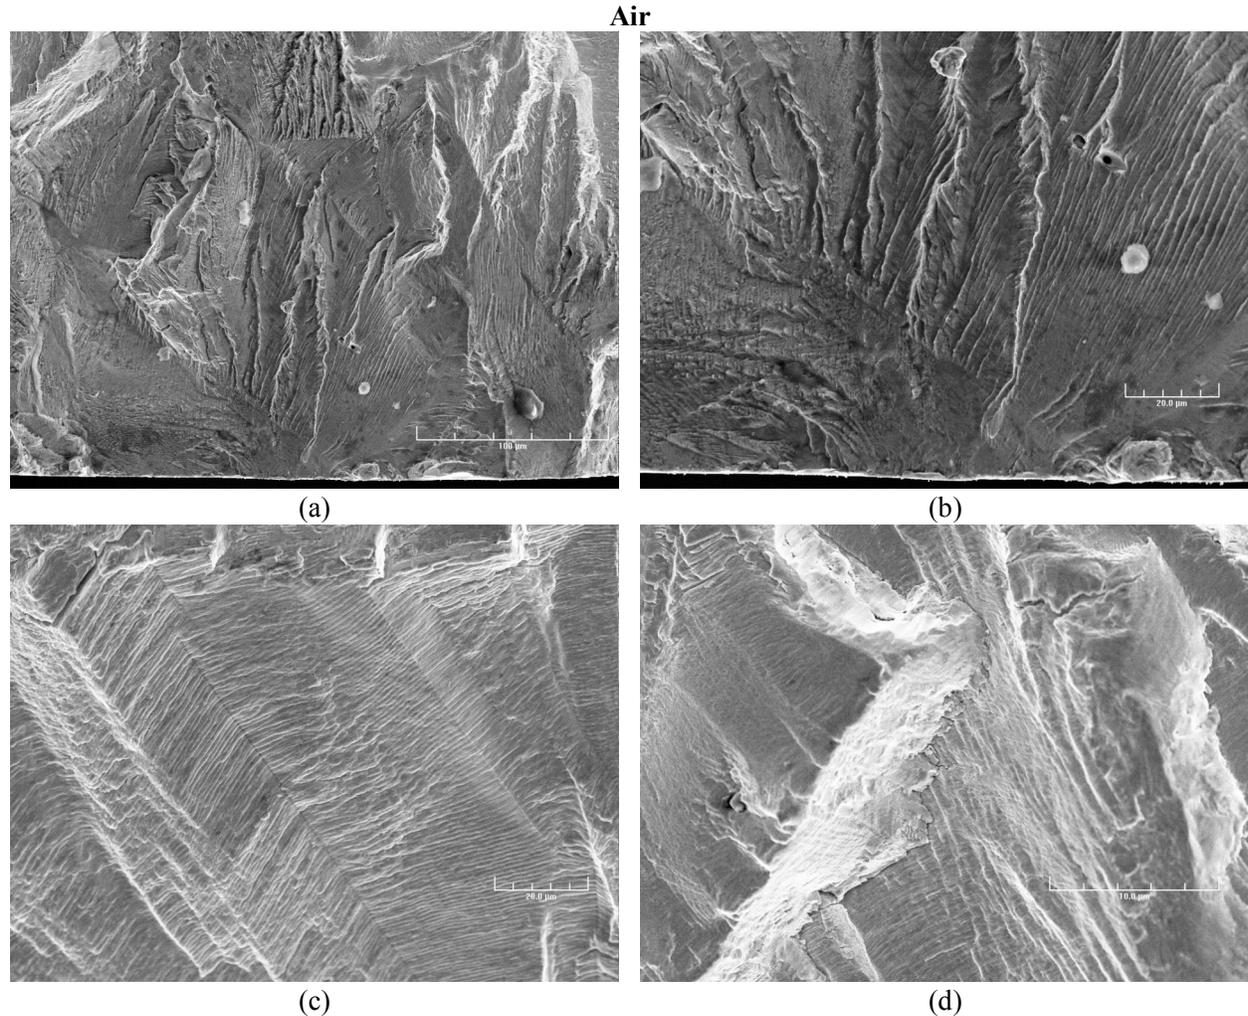
Figure 16. Photomicrographs showing crack initiation site at (a) low and (b) high magnification, and (c,d) striations at select locations in Type 316NG SS tested in air.

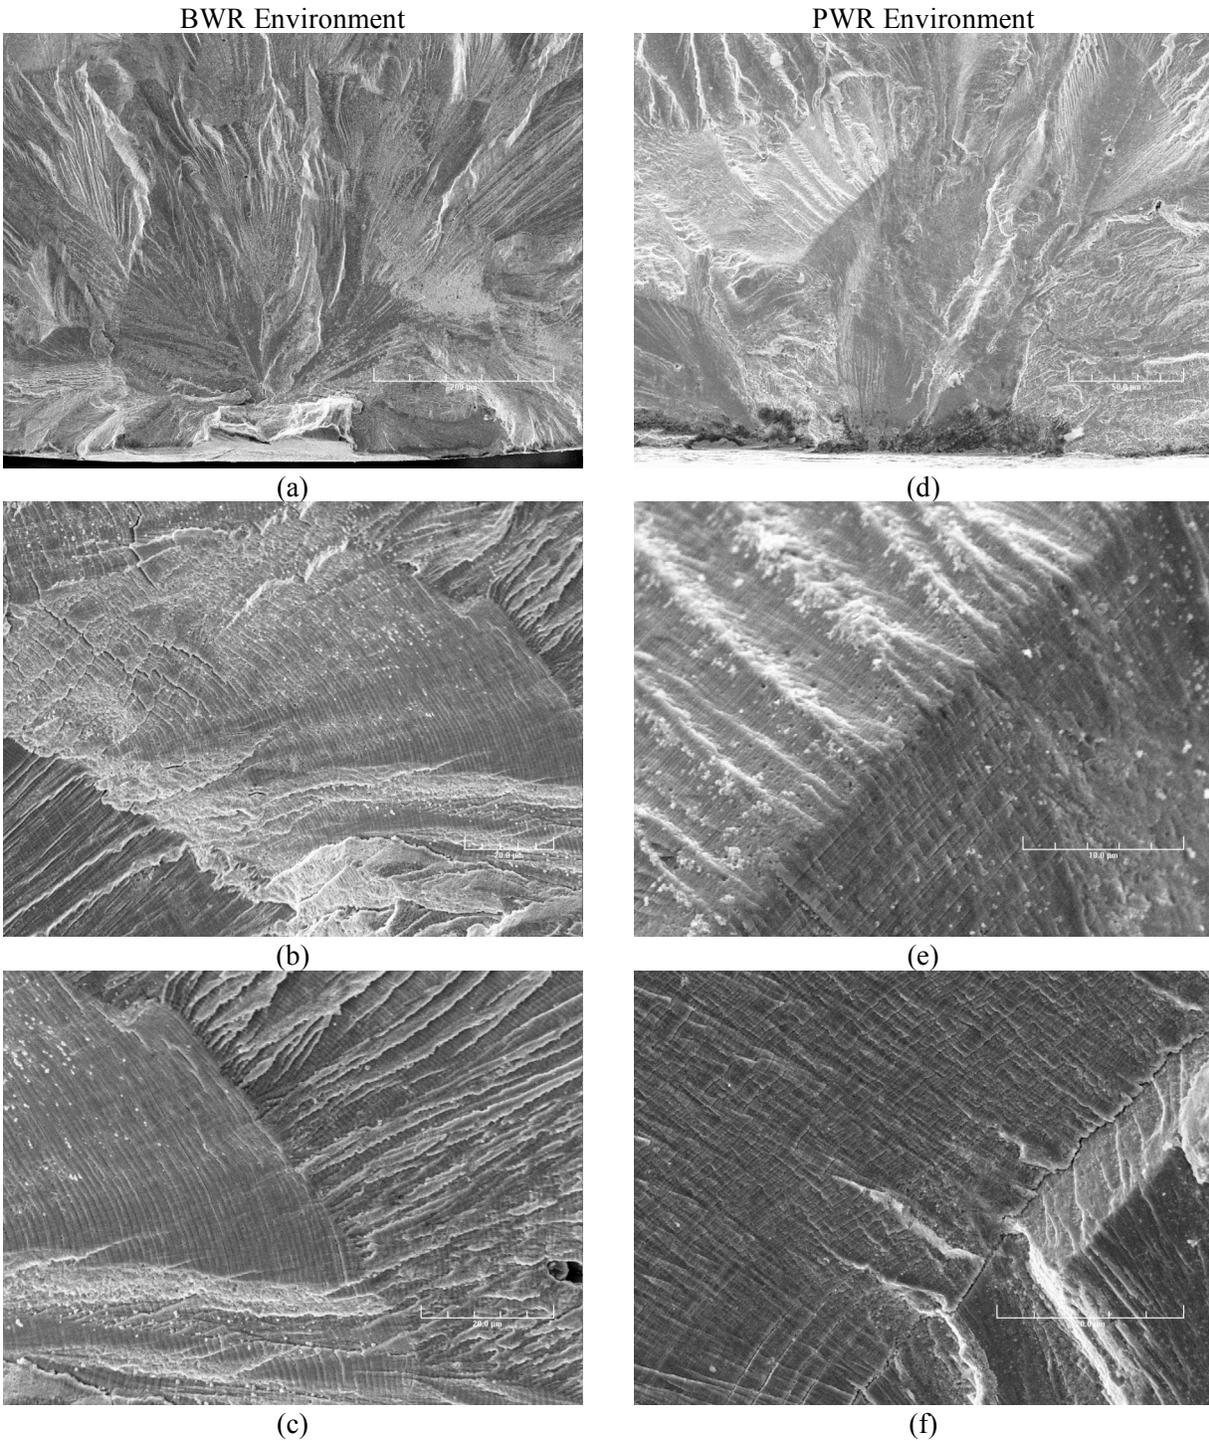
In a high-DO BWR environment, Fig. 17a-c, cracking was also initiated and propagated in TG mode, with riverlike patterns on the facets. Within 200  $\mu\text{m}$  of the initiation site, fatigue striations were observed on some facets (Figs. 17b and c). Similarly, for specimens tested in a low-DO PWR environment (Fig. 17d), crack initiation and crack propagation are TG, with cleavage-like fracture facets

that exhibit river patterns. The higher magnification photomicrographs (at a location seen in Fig. 17d) show fatigue striations within 200  $\mu\text{m}$  of the initiation site. Evidence of rubbing due to repeated contact between the two mating surfaces can also be observed in Fig. 17f.

Figure 17. Photomicrographs showing crack initiation site and striations at select locations in Type 316NG SS tested in (a–c) BWR and (d–f) PWR environment.

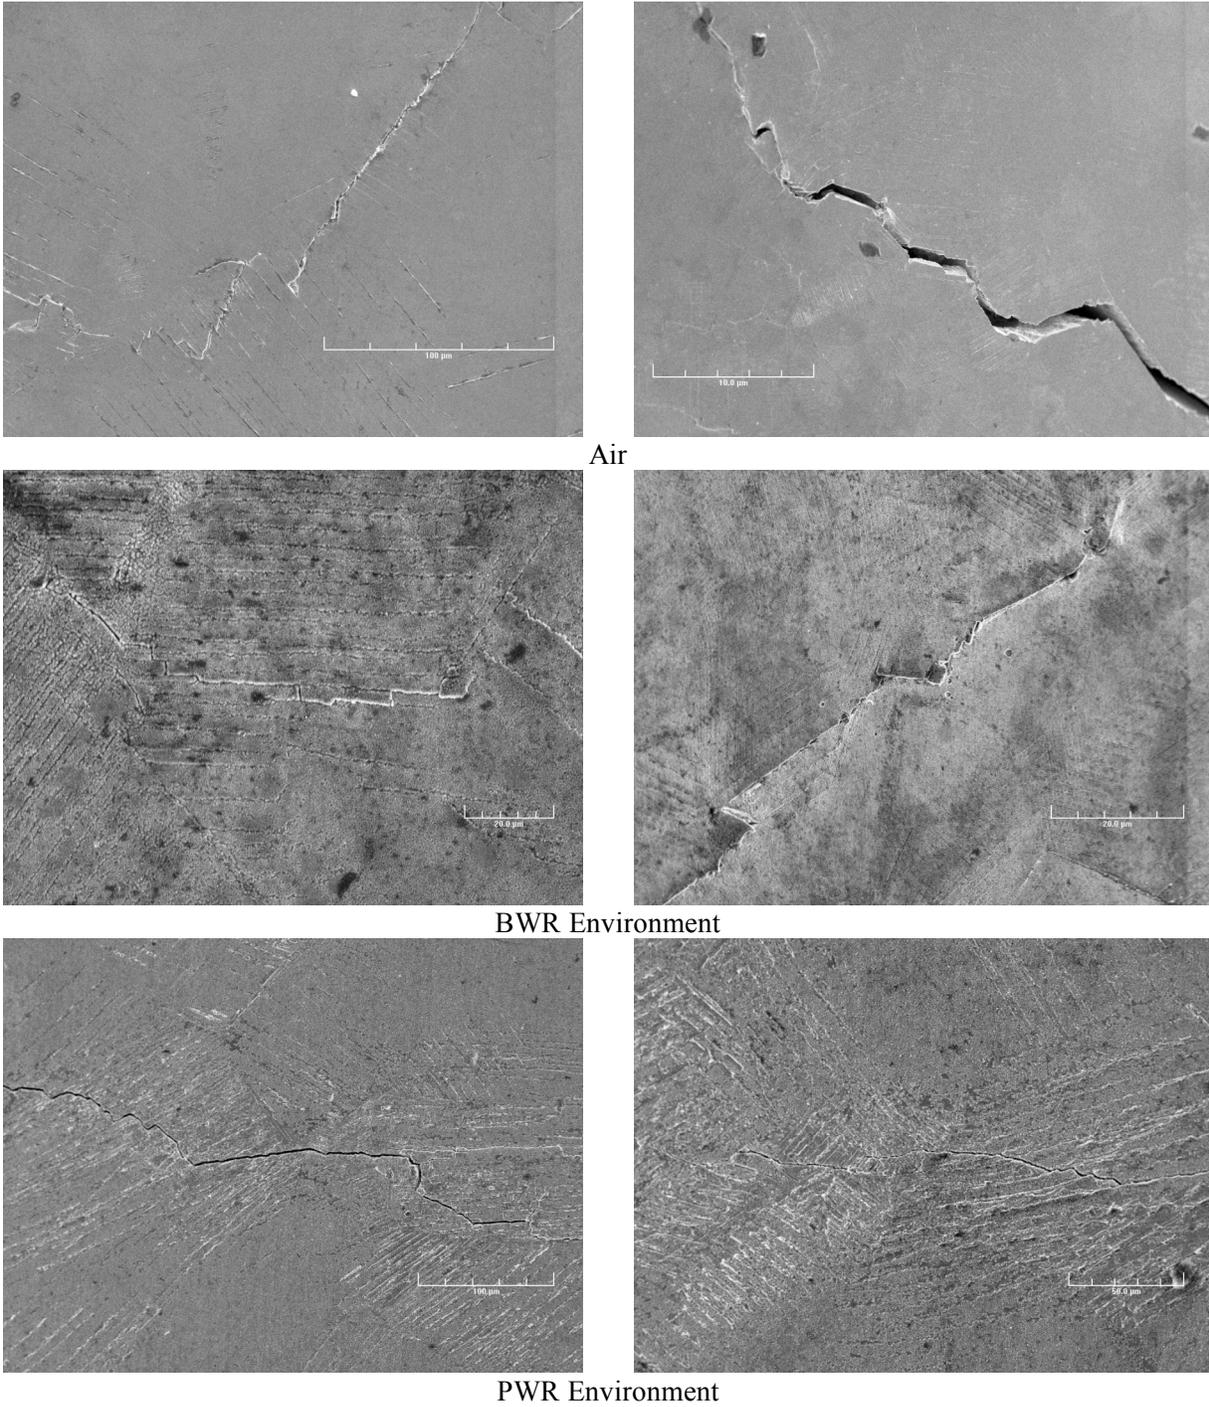
Figure 18 presents photomicrographs that show the crack morphology in Type 316NG SS in three environments. In all cases, the tensile axis is vertical, parallel to the plane of each picture. The general appearance is that, for air tests, the cracks are more likely to be oblique, approaching 45° with respect to the tensile axis. By contrast, the cracks that formed in the BWR environment appeared mixed, both oblique and normal to the tensile direction, while the cracks that formed in the PWR environment appeared mostly perpendicular to the tensile axis.

Figure 18. Photomicrographs showing the morphology of lateral cracks formed in Type 316NG SS in three test environments.

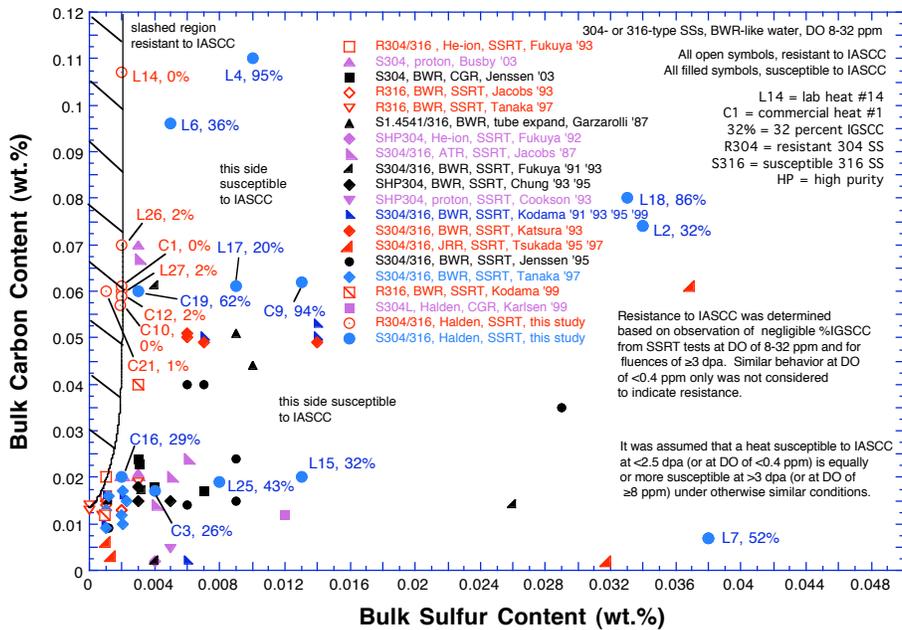
under otherwise identical conditions. Note that, in these figures, the plotted ranges of S and C contents extend beyond the AISI limits specified for Type 304 and 316 SS, i.e., maximum S = 0.030 wt.% and maximum C = 0.08 wt.%.

Figure 19. Range of bulk S and C contents in which 304- or 316-type steels are resistant or susceptible to IASCC in BWR-like oxidizing water.

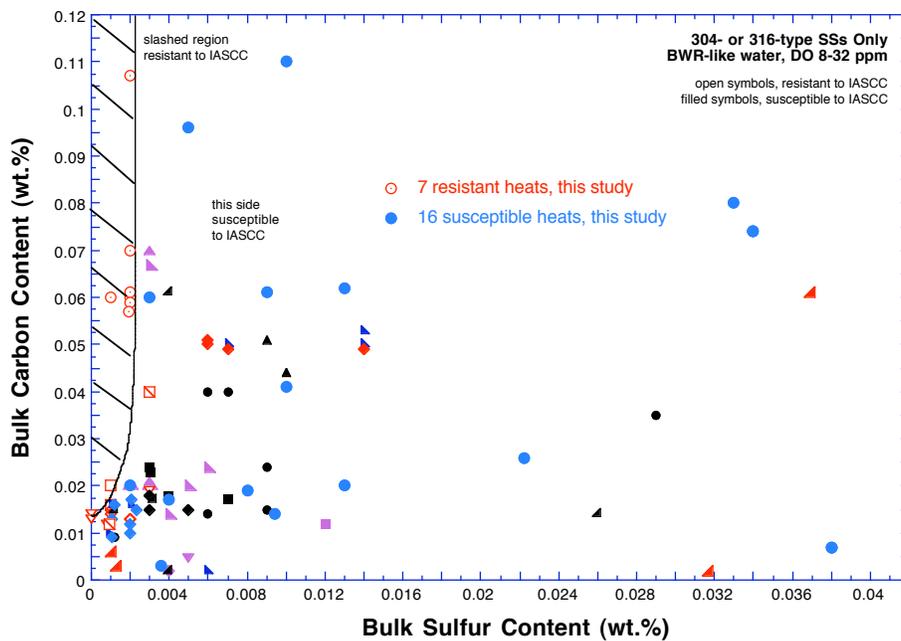
In Fig. 21, which is similar to Fig. 19, data points for four susceptible heats tested after irradiation to 1.3 dpa (i.e., Heats L22, L11, L13, and L8) are also included. It was assumed that the four heats are also susceptible to IASCC at 3 dpa, although they were not tested at this damage level.

Figure 21. Range of bulk S and C contents in which 304- or 316-type steels are resistant or susceptible to IASCC, including four susceptible heats tested at 1.3 dpa in this study.

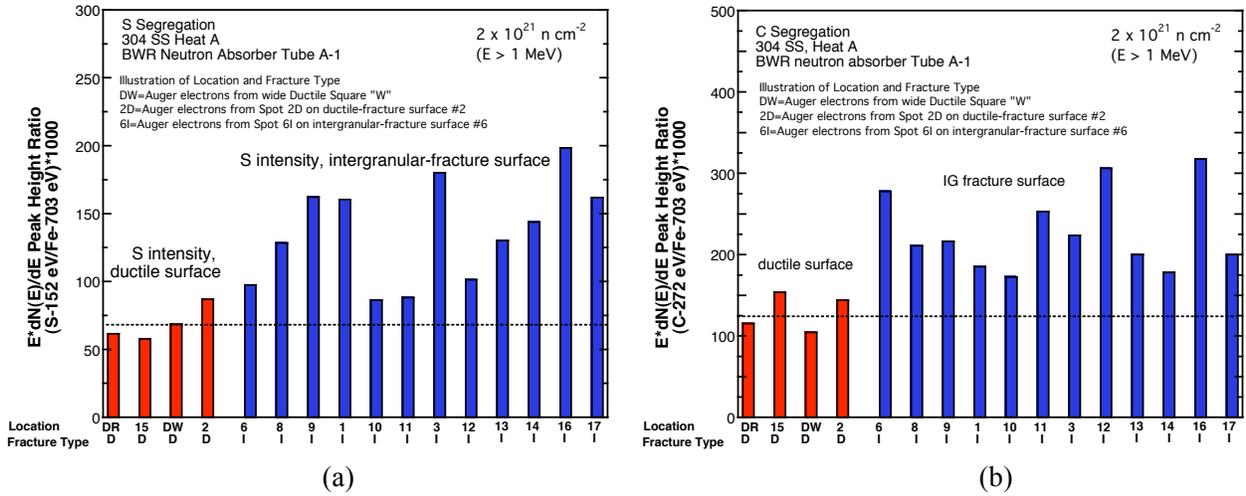
Figure 23. Summary of AES analysis of grain-boundary segregation of S (a) and C (b) in BWR neutron absorber tube fabricated from Type 304 SS Heat A and irradiated to 3 dpa: S and C peak heights from ductile (denoted “D”) and IG (denoted “I”) fracture surfaces are compared.

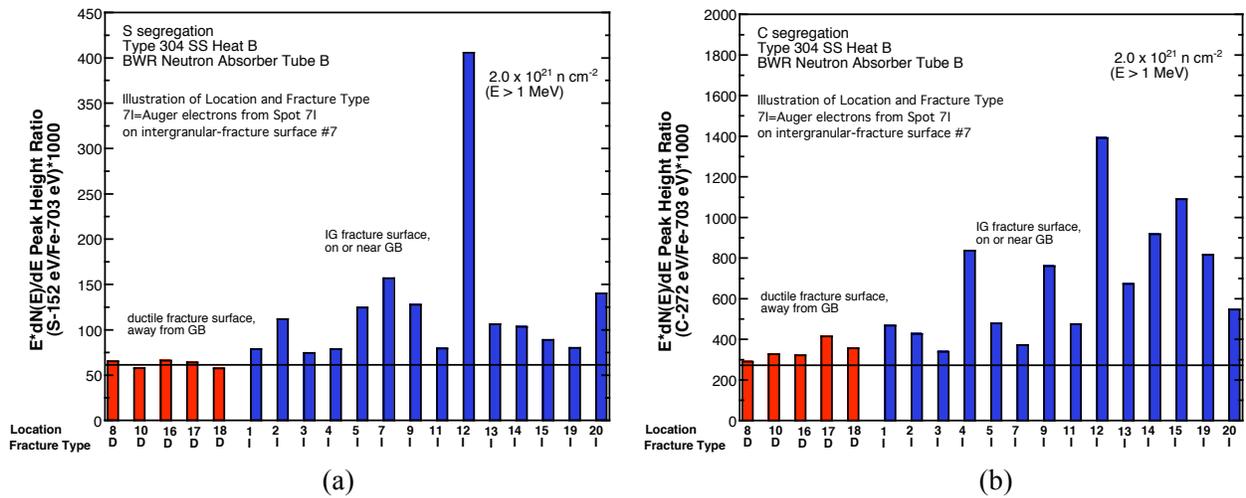
Figure 24. Summary of AES analysis of grain-boundary segregation of S (a) and C (b) in BWR neutron absorber tube fabricated from Type 304 SS Heat B and irradiated to 3 dpa: S and C peak heights from ductile (denoted “D”) and IG (denoted “I”) fracture surfaces are compared.

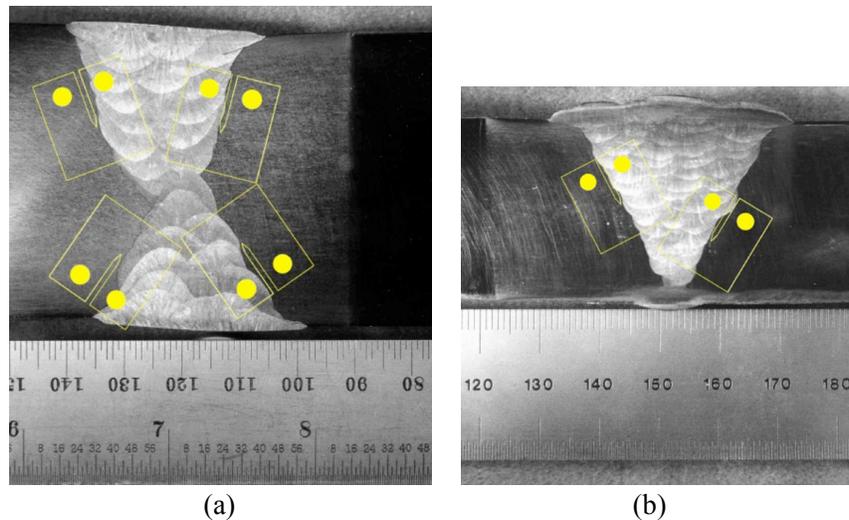
Figure 30. Orientation of the 1/4-T CT specimens from the (a) Grand Gulf H5 SA weld HAZ and (b) laboratory-prepared SMA weld HAZ.

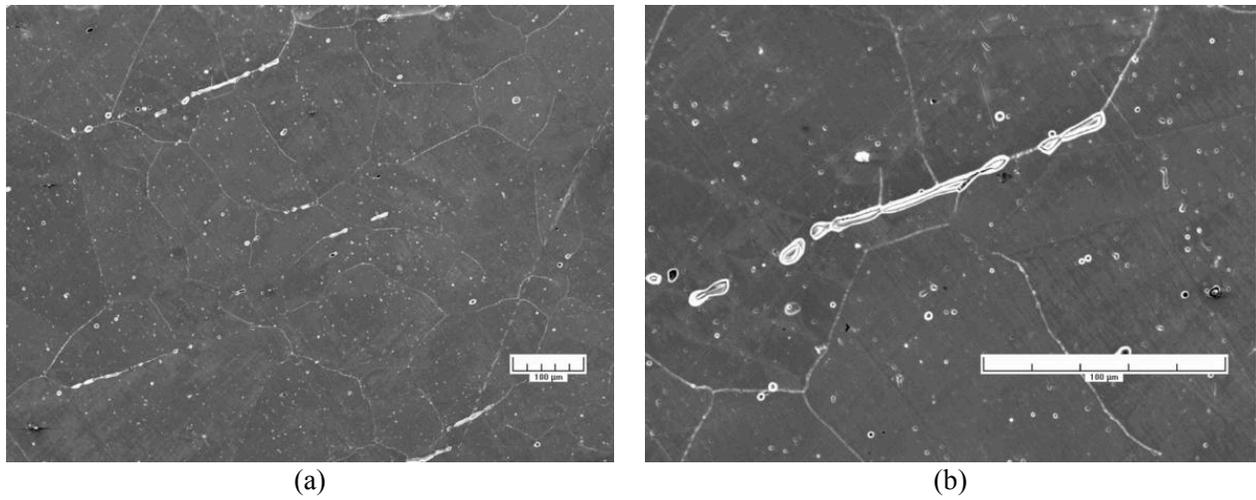
Figure 31. (a) Low- and (b) high-magnification photomicrographs of the structure of the Type 304L base metal from the top shell of the H5 weld of the Grand Gulf core shroud.

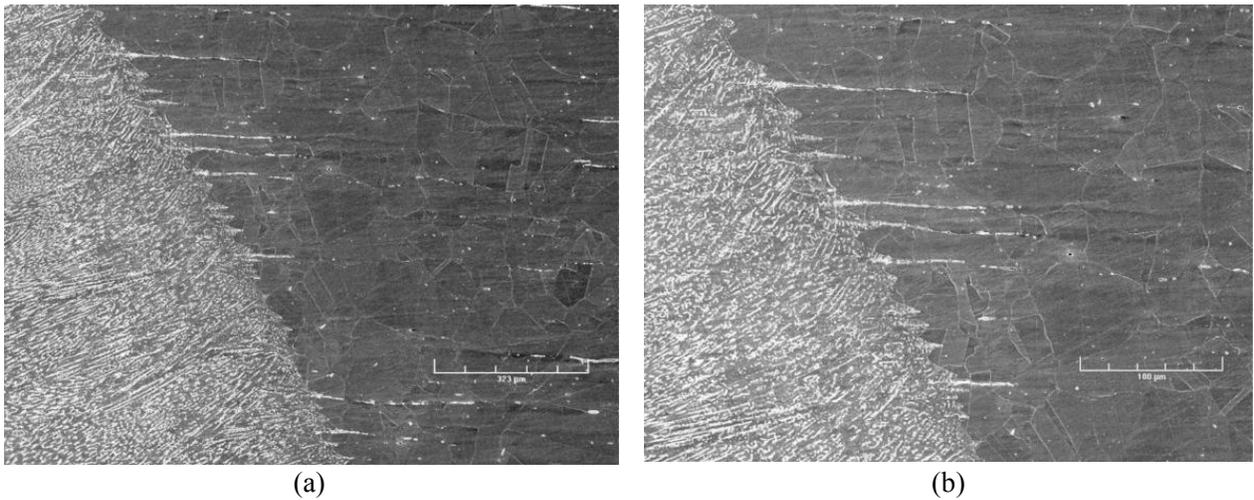
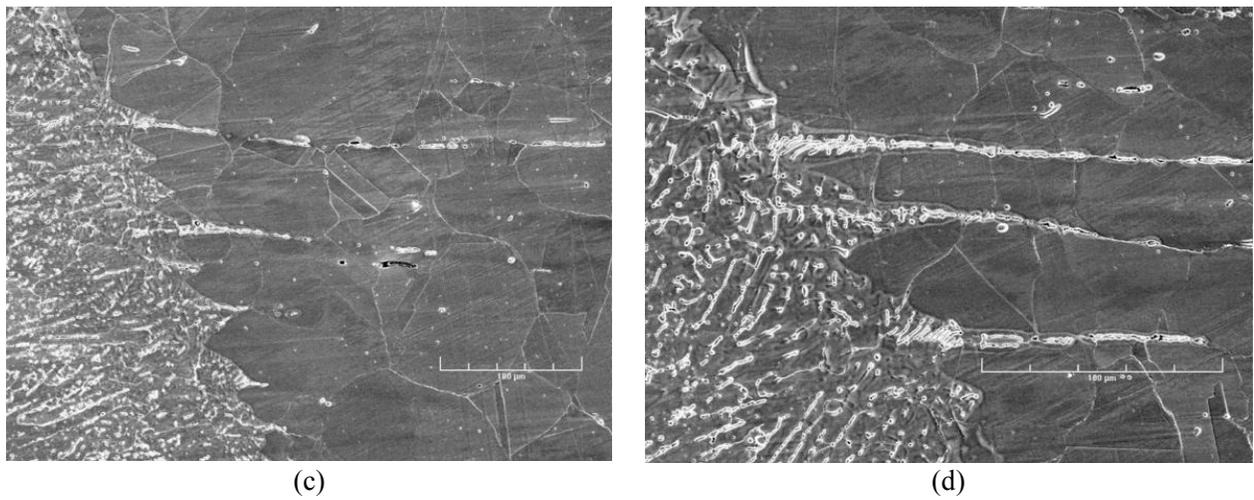
Figure 36. Micrographs of the interface between the weld metal and base metal.

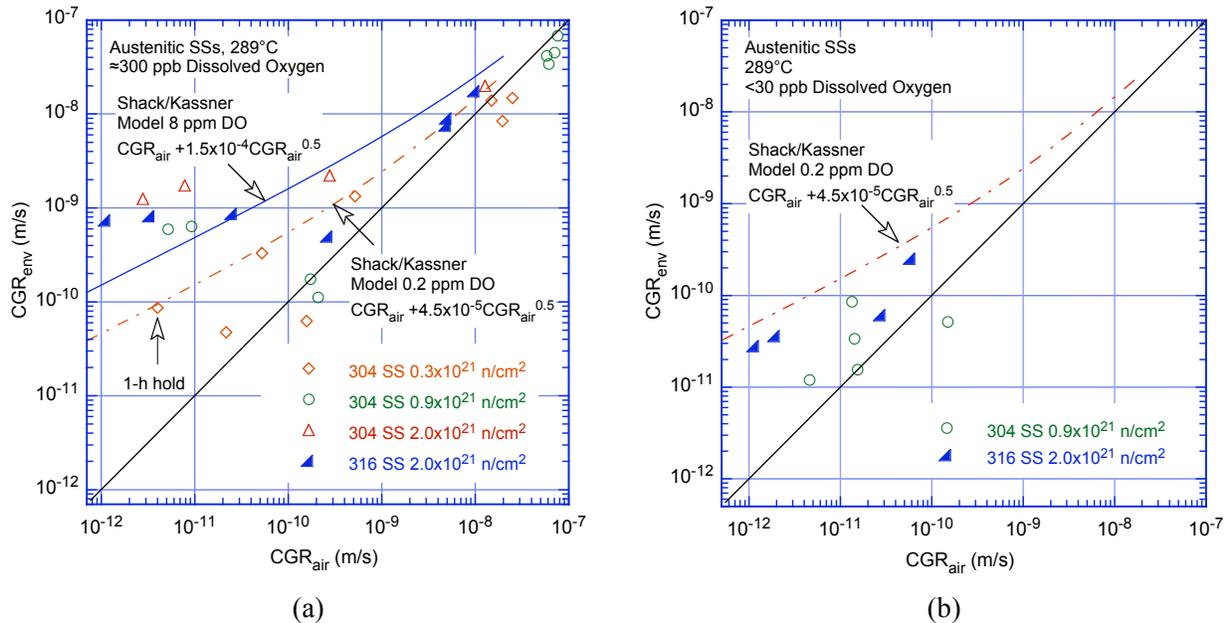
Figure 40. CGR data for irradiated austenitic SSs under continuous cycling at 289°C in high-purity water with (a)  $\approx 300$  ppb and (b)  $< 30$  ppb dissolved oxygen.

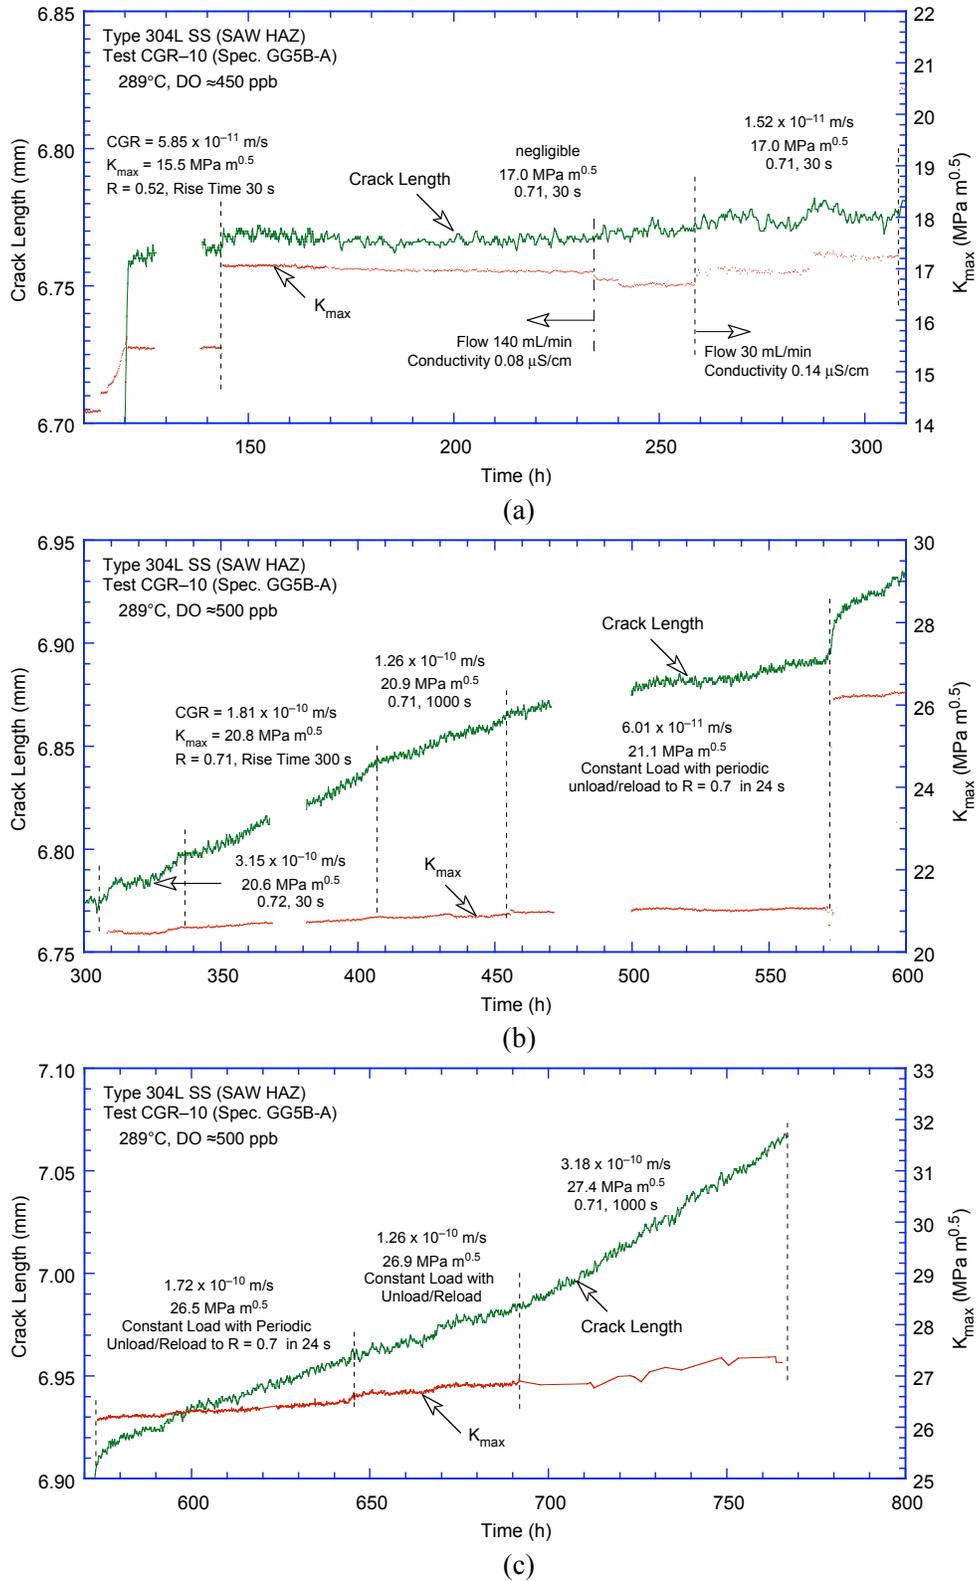
Figure 42. Crack length vs. time plots for nonirradiated HAZ specimen of Grand Gulf Type 304L bottom shell H5 weld in high-purity water at 289°C during test periods (a) precracking–3, (b) 4–6, and (c) 7–8.

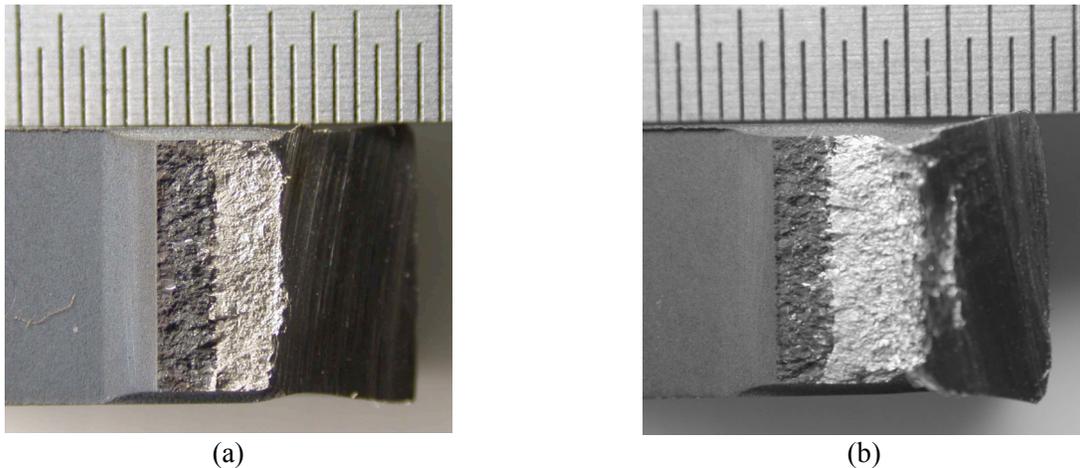
Figure 43. Photomicrograph of the fracture surface of Specimen GG5B-A.

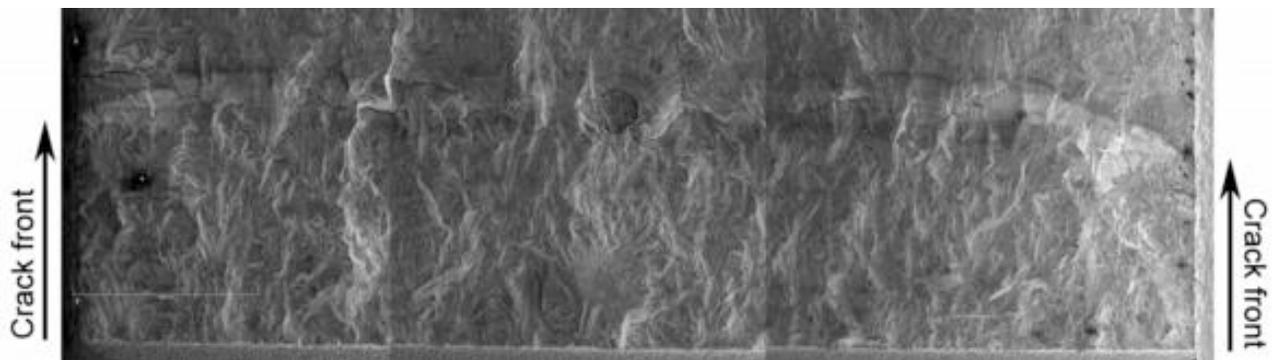
Figure 44. Micrograph of the fracture surface of Specimen GG5B-A tested in high-DO water at 289°C.

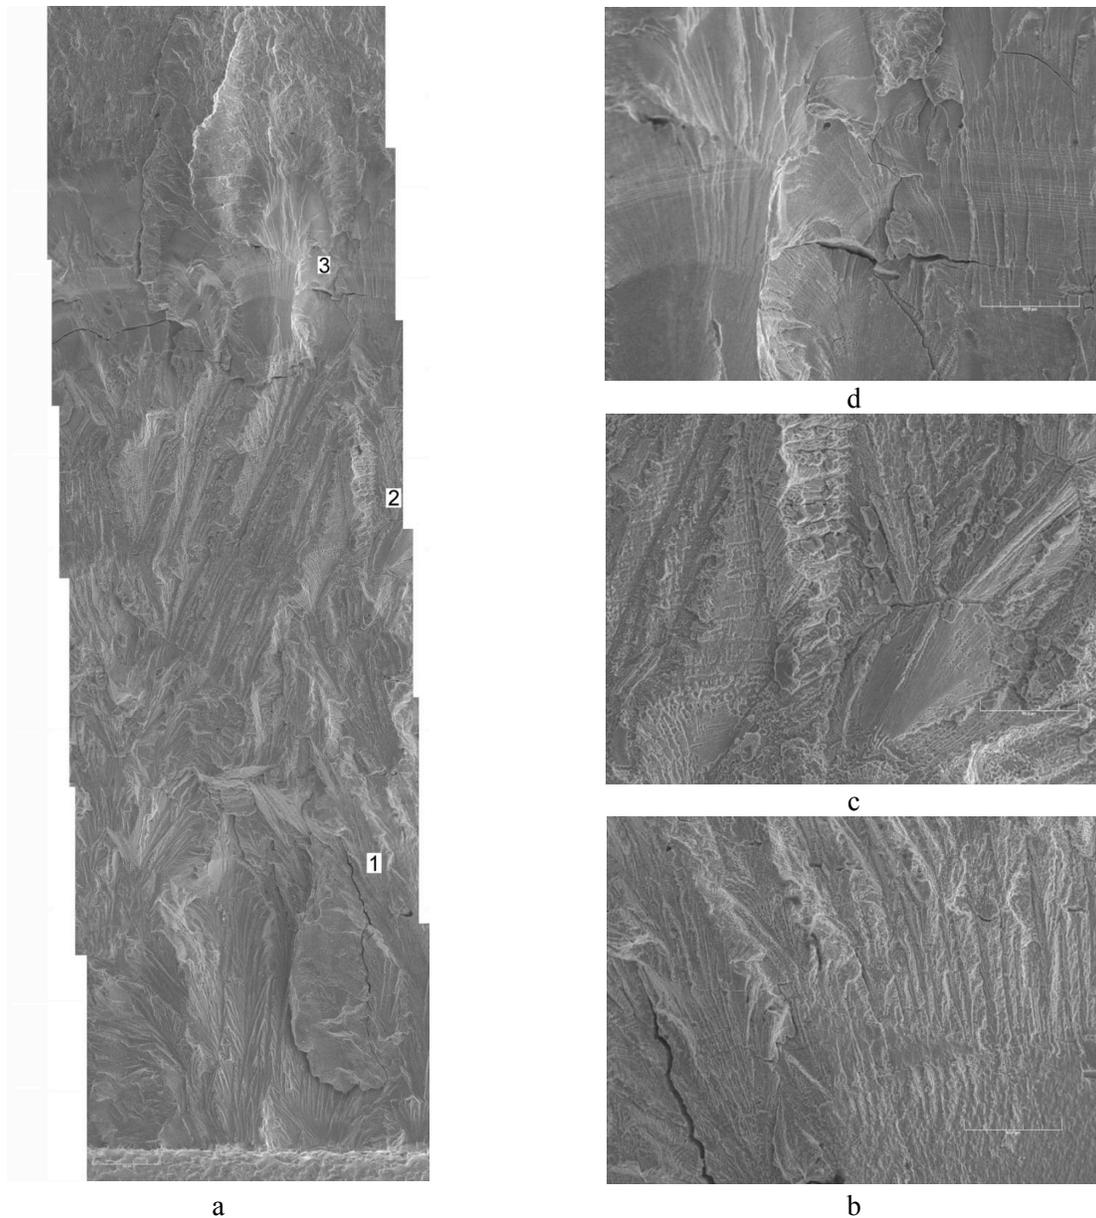
Figure 45. Micrographs showing (a) slice of the entire length of fracture surface, and (b), (c), and (d) high magnification micrographs of the fracture surface at locations 1, 2, and 3, respectively.

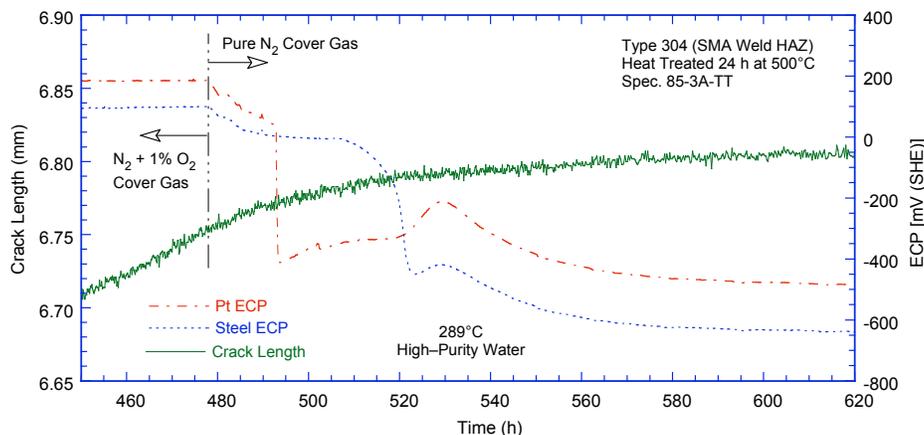
Figure 46. Change in crack length and ECP of Pt and SS electrodes during test periods 5–6 and the intermediate transition period.

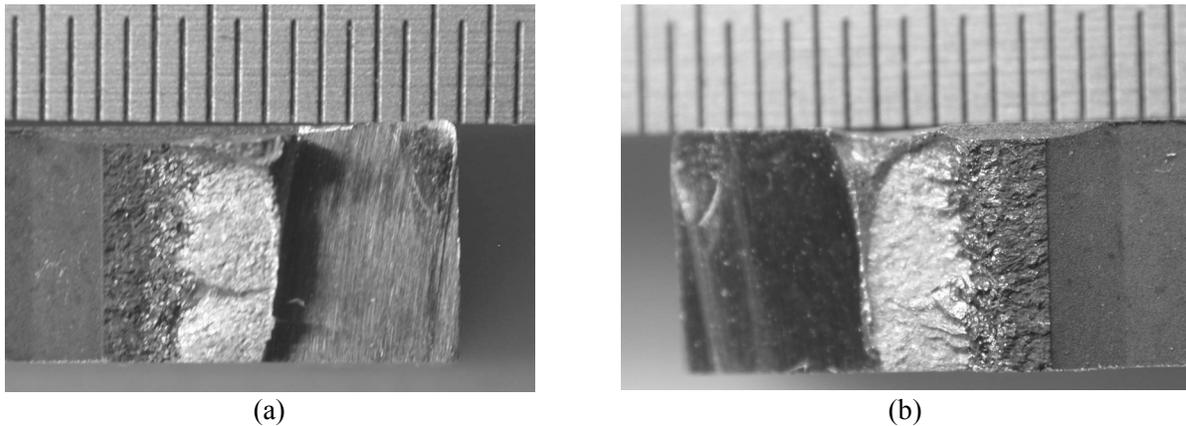
Figure 47. Photomicrographs of the fracture surfaces of the two halves of Specimen 85-3A-TT.

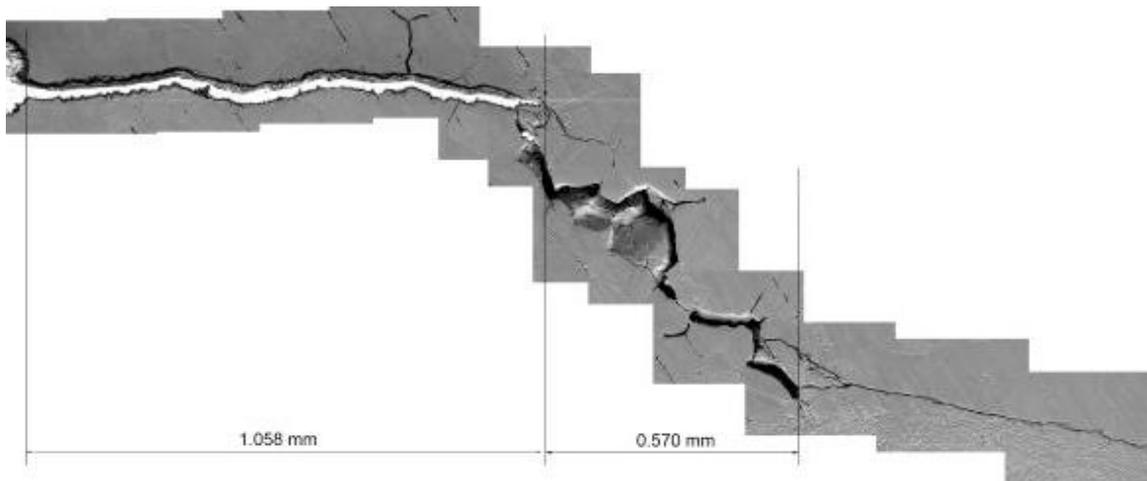
Figure 48. Micrograph of the cross section of Specimen 85-3A-TT showing the fracture plane profile.
