# Environmentally Assisted Cracking in Light Water Reactors

Annual Report  
January—December 2003

Prepared by  
B. Alexandreanu, O. K. Chopra, H. M. Chung,  
E. E. Gruber, and W. J. Shack

Argonne National Laboratory  
9700 South Cass Avenue  
Argonne, IL 60439

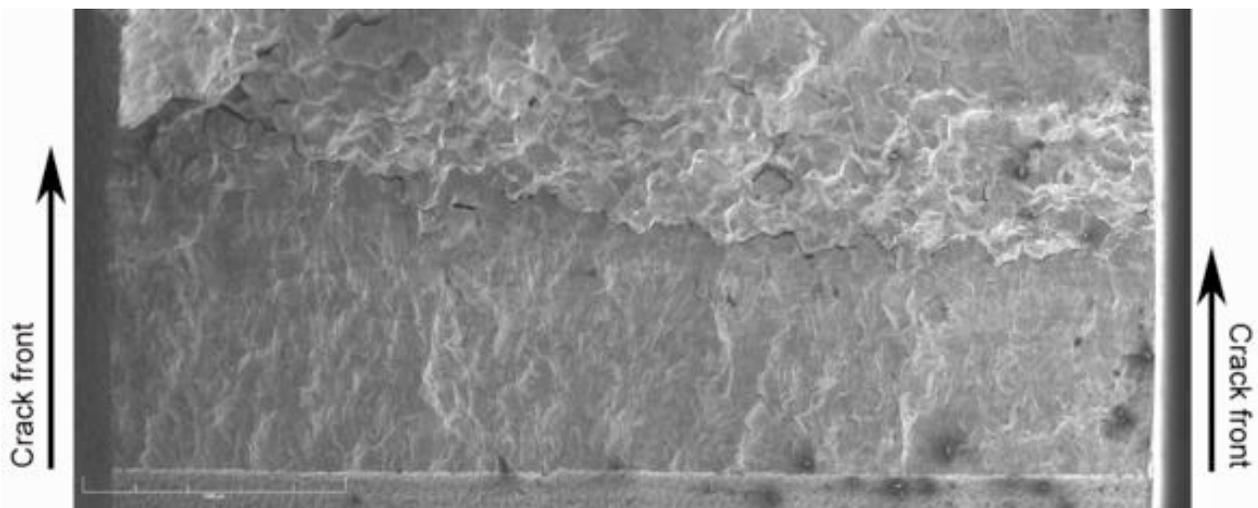
Figure 50. Micrograph of the fracture surface of Specimen 85-3A-TT tested in high-DO water at 289°C.

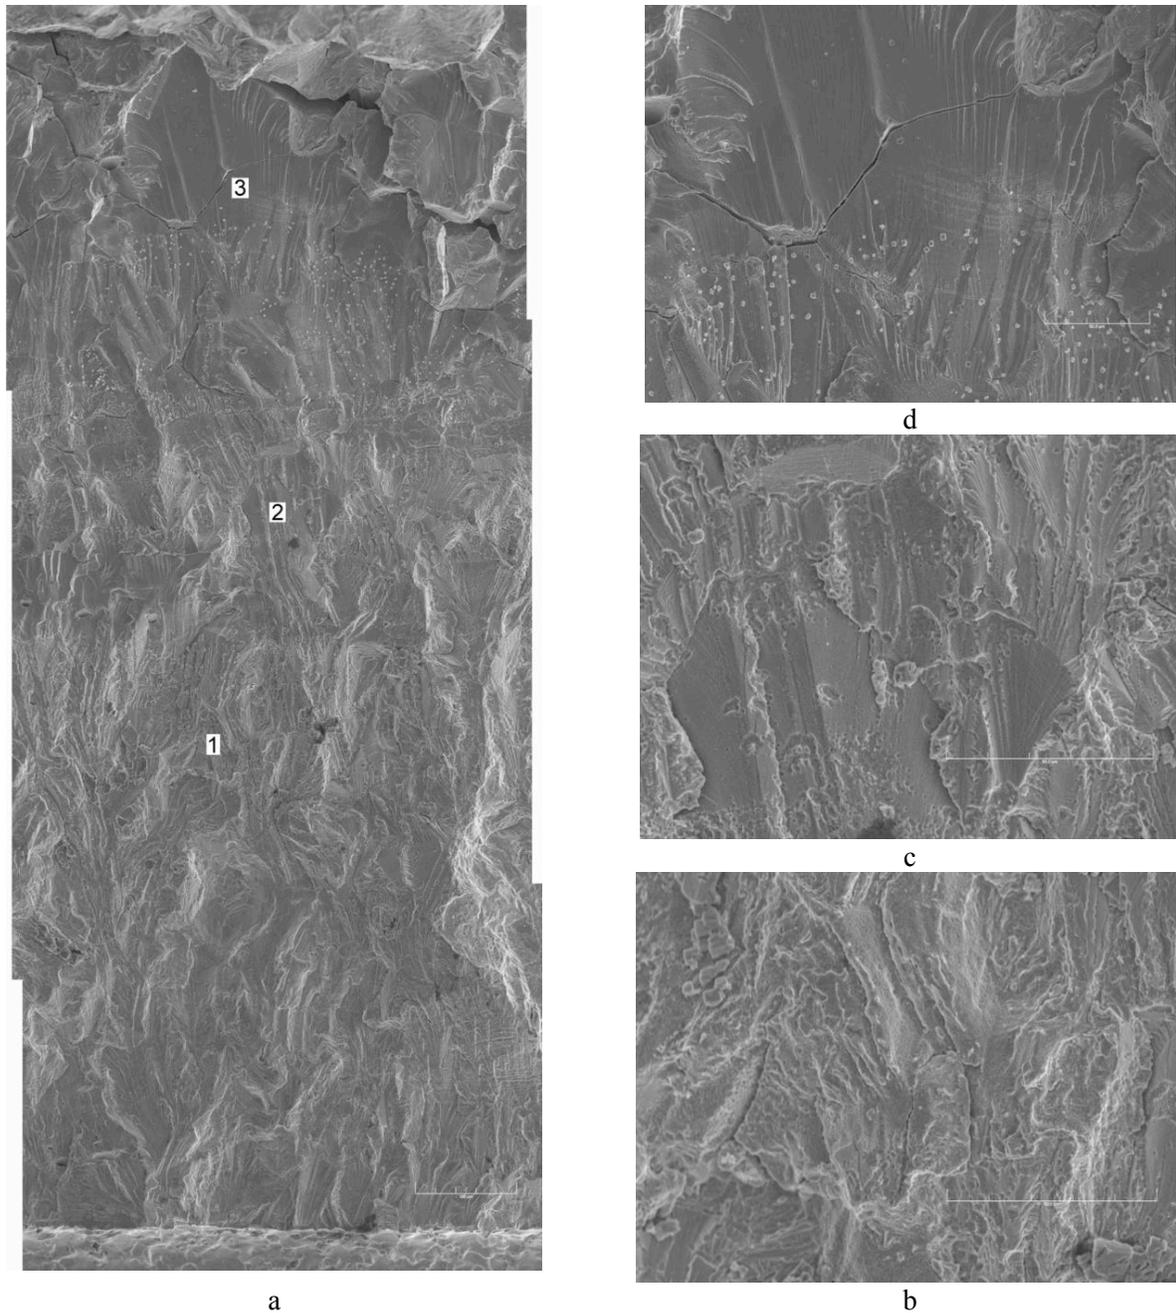
Figure 51. Micrograph showing (a) slice of the fracture surface that was perpendicular to the stress axis, and (b), (c), and (d) high-magnification micrographs of the fracture surface at locations 1, 2, and 3, respectively.

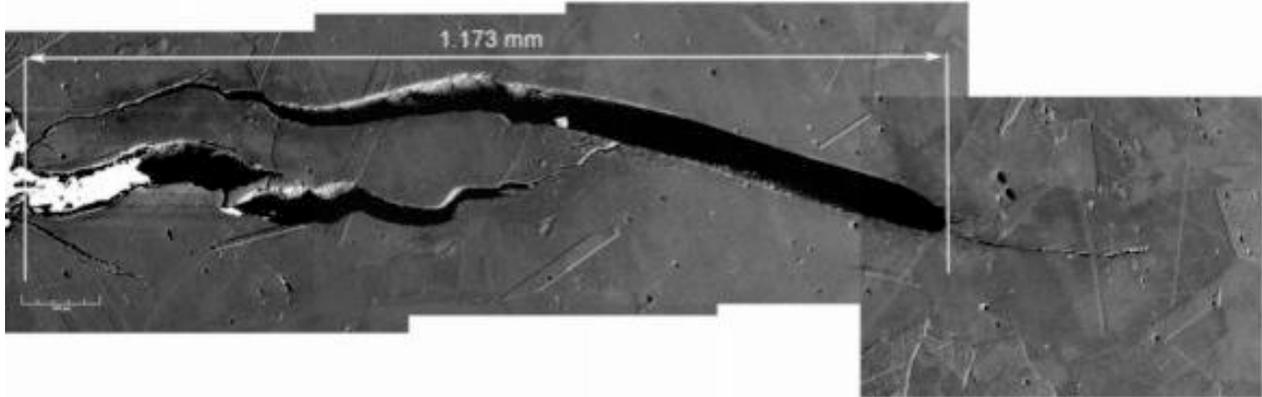
Figure 53. Micrograph of the cross section of Specimen GG3B-A-TT showing the fracture plane profile.

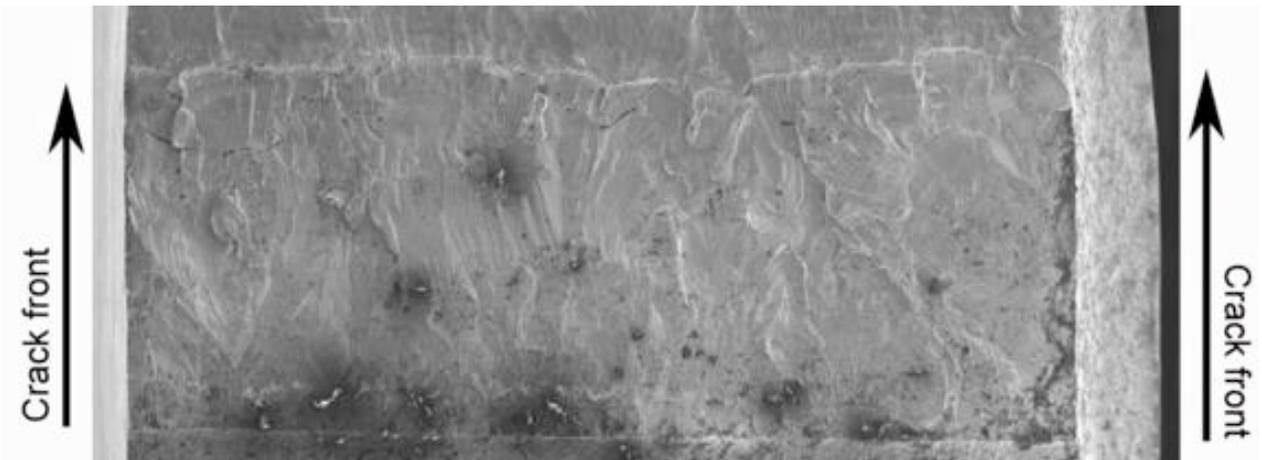
Figure 54. Micrograph of the fracture surface of Specimen GG3B-A-TT tested in high-DO water at  $289^{\circ}\text{C}$ .

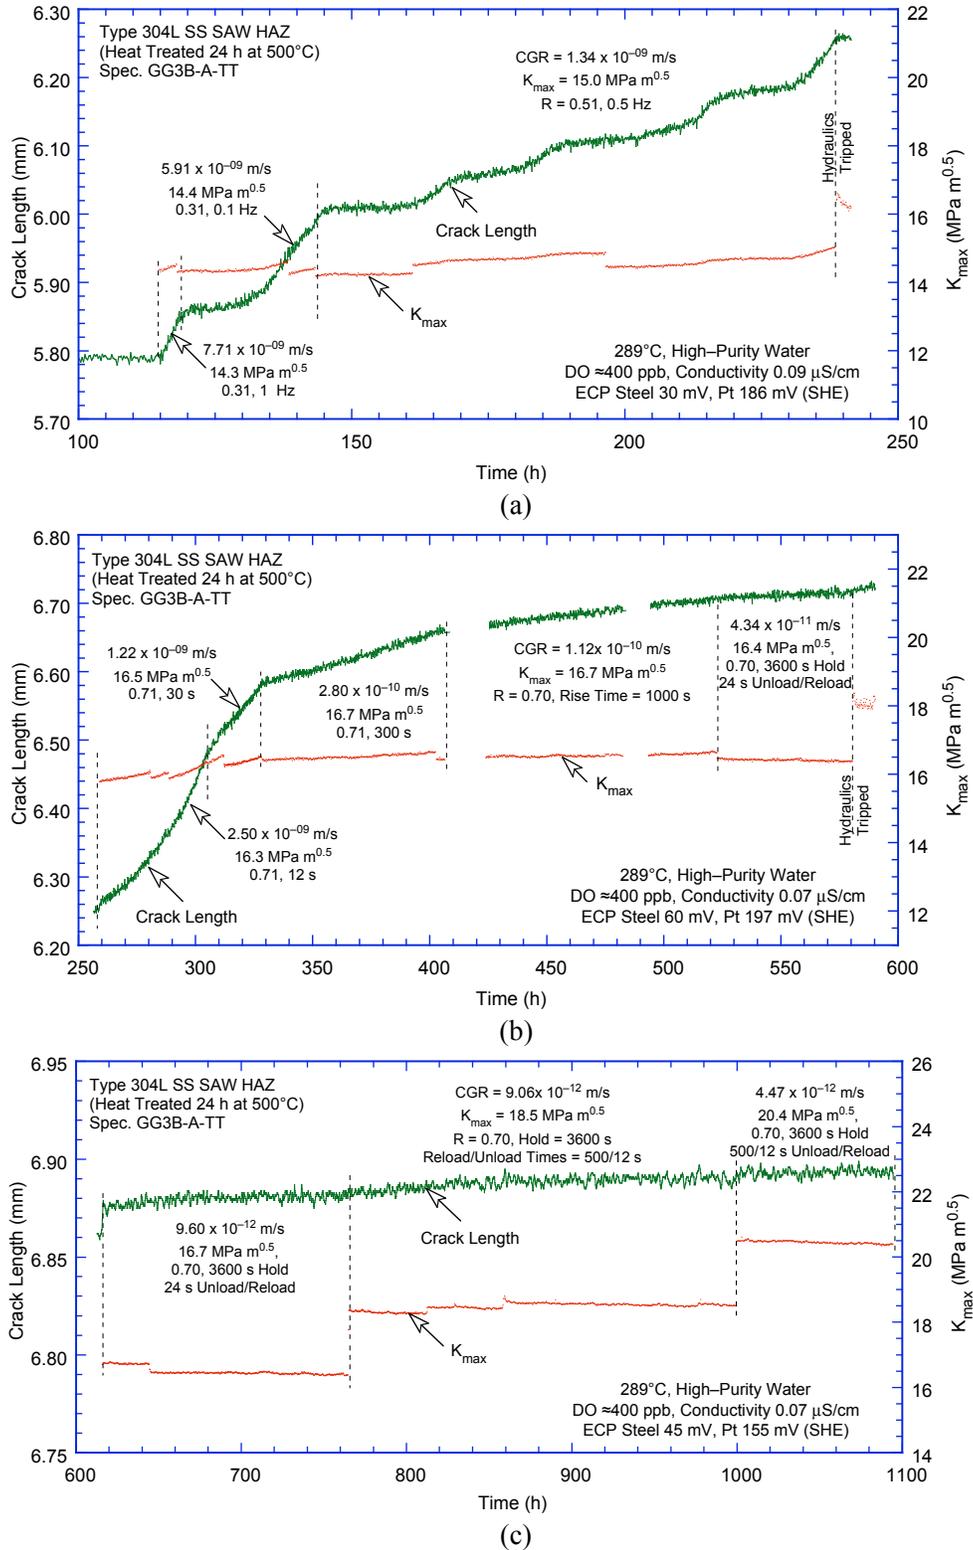
Figure 55. Crack length vs. time plots for nonirradiated thermally treated Type 304L bottom shell HAZ from the Grand Gulf H5 SA weld in high-purity water at 289°C during test periods (a) precracking, (b) 1-5, and (c) 5-7.

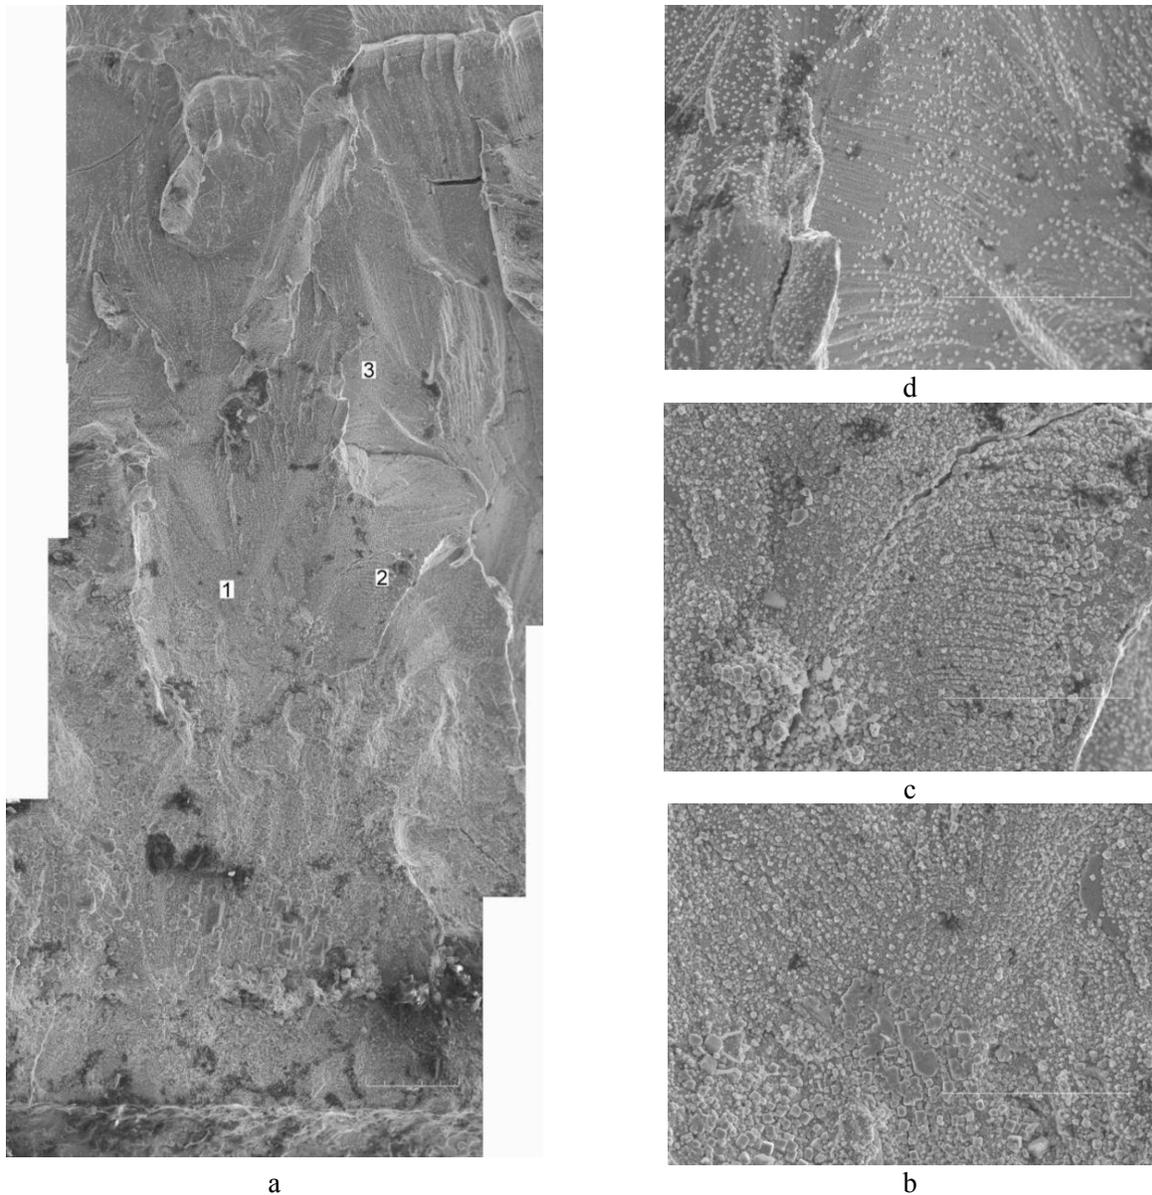
Figure 56. Micrographs showing (a) slice of the entire length of the fracture surface and (b), (c), and (d) high-magnification micrographs of the fracture surface at locations 1, 2, and 3, respectively.

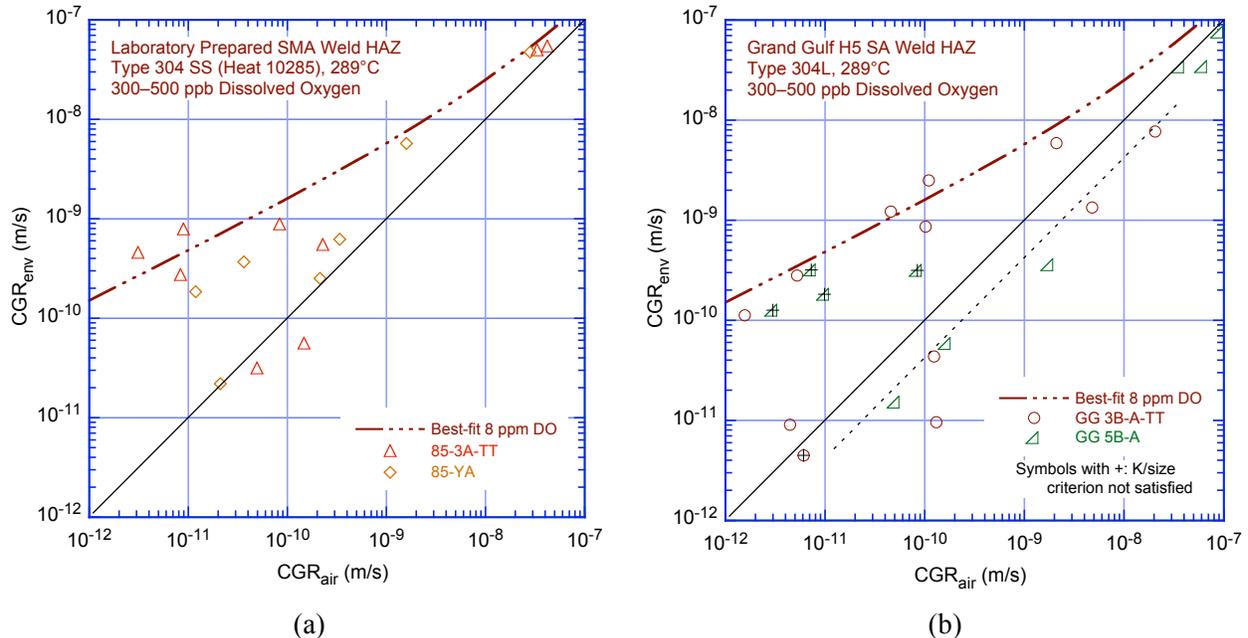
Figure 57. CGR data for nonirradiated specimens of (a) laboratory-prepared Type 304 SS SMA weld HAZ and (b) Type 304L SA weld HAZ from the Grand Gulf core shroud under continuous cycling at 289°C in high-purity water with 300–500 ppb dissolved oxygen

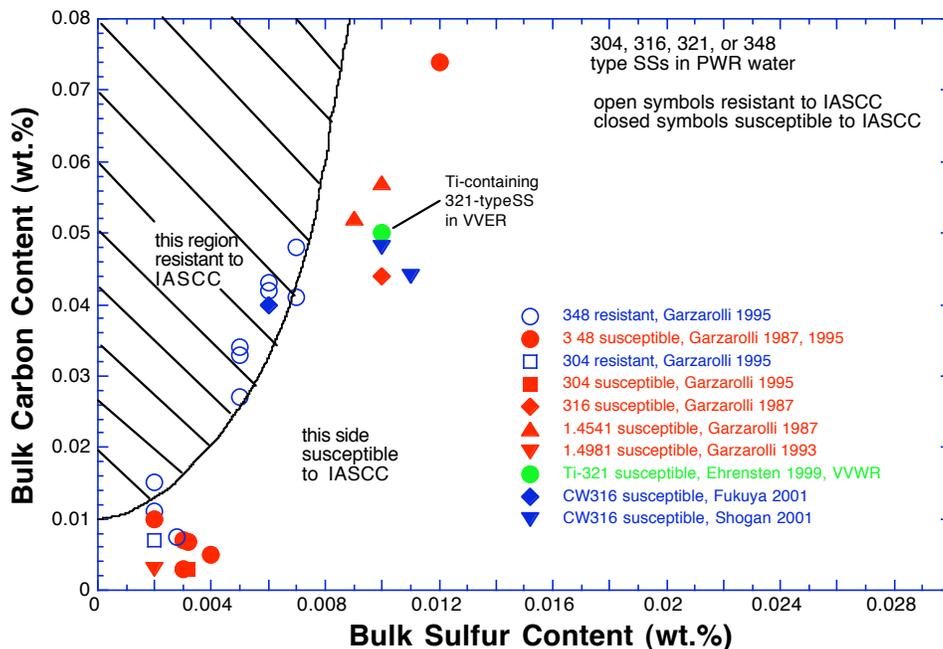
Figure 59. Representation of IASCC resistance or susceptibility of austenitic stainless steels as function of bulk S and C contents. Data obtained from PWR– or VVER–irradiated specimens in PWR, VVER, or PWR–like water reported in 1987–2004.

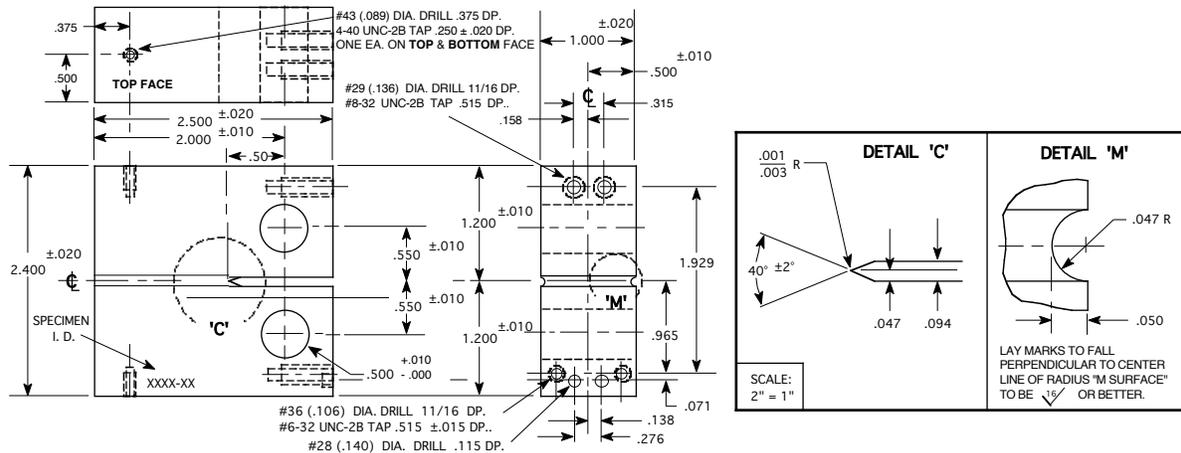
Figure 60. Configuration of compact-tension specimen used for this study (dimensions are in inches).

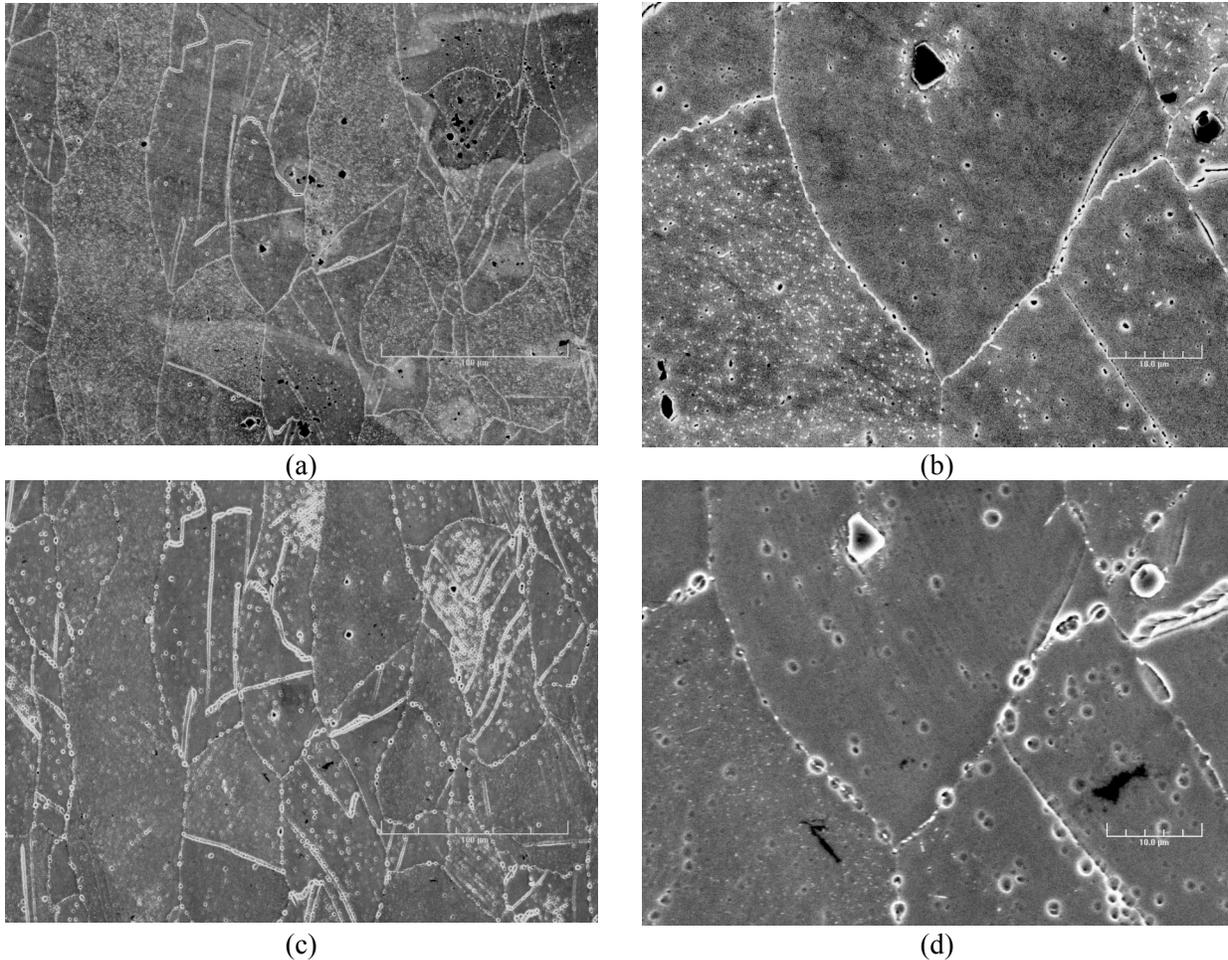
Figure 63. Microstructure of the round robin Alloy 600 etched with (a, b) nital and (c, d) phosphoric acid solution.

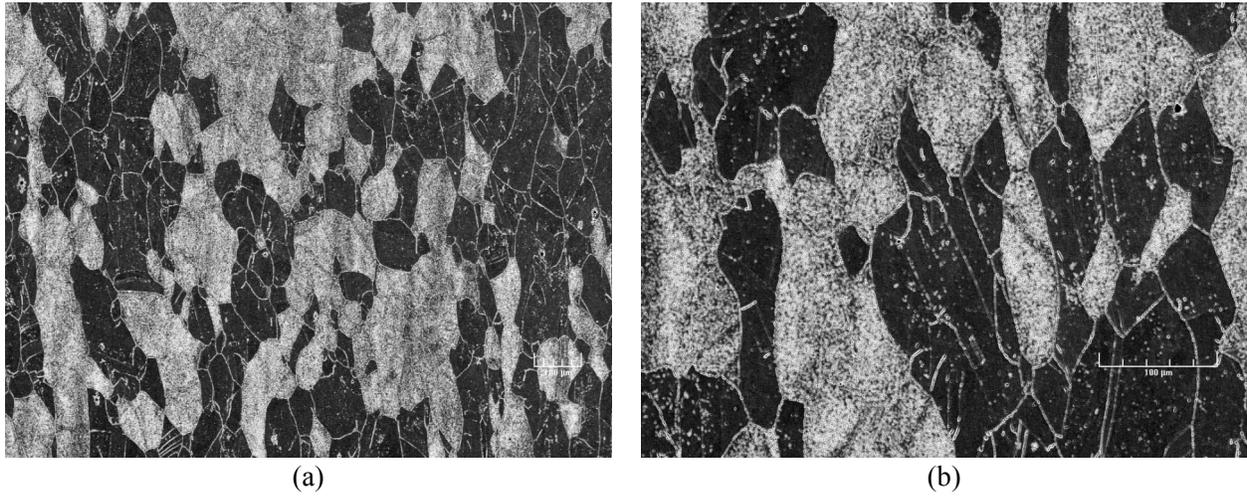
Figure 64. Microstructure of the round robin alloy in the plane of the crack at two magnifications.

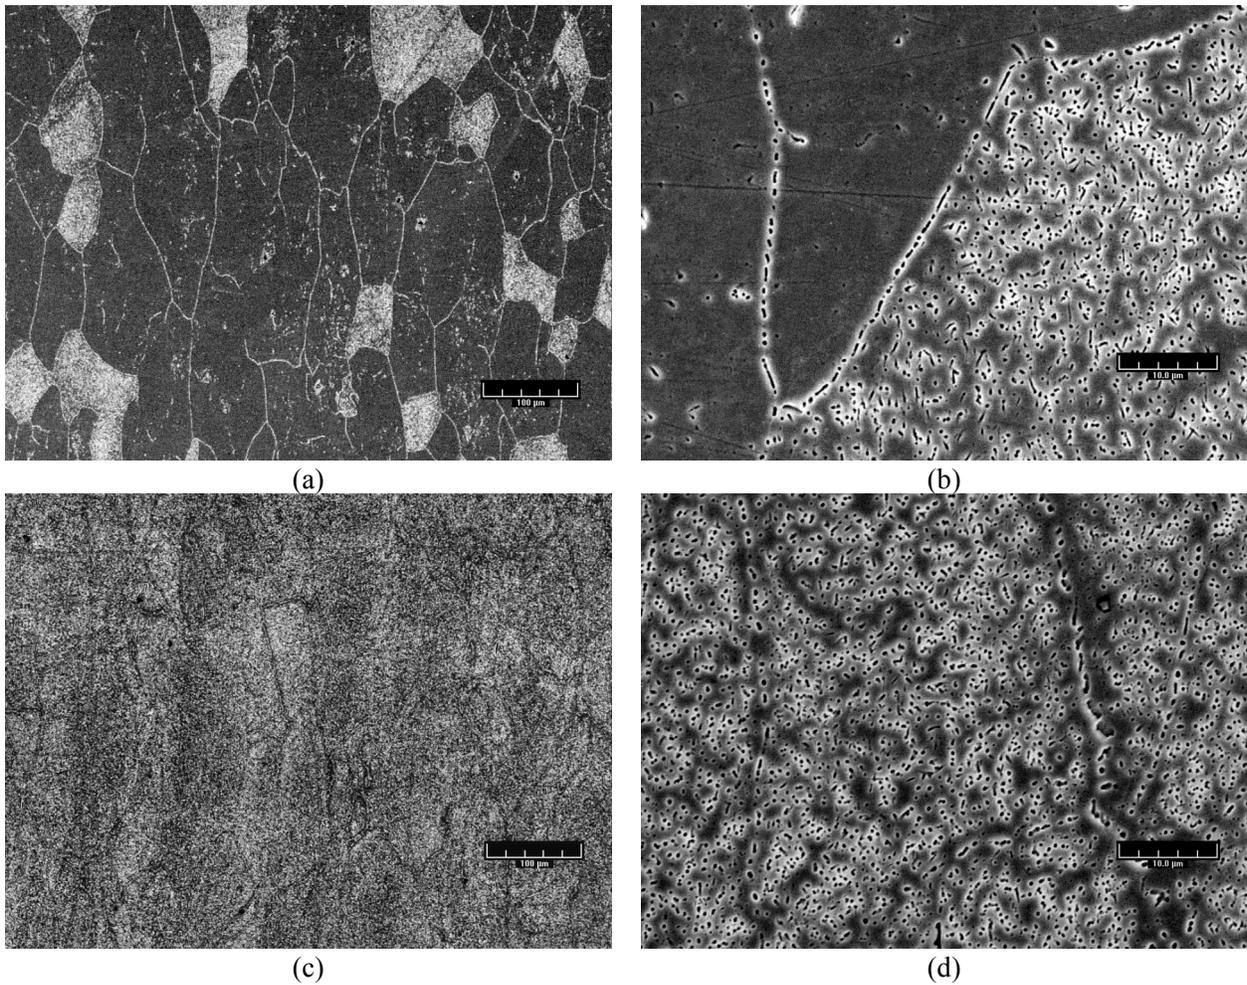
Figure 65. Microstructure of the round robin alloy in the plane of the crack at two magnifications (a,b) and that of a different heat of Alloy 600, used previously in our experiments (c, d).

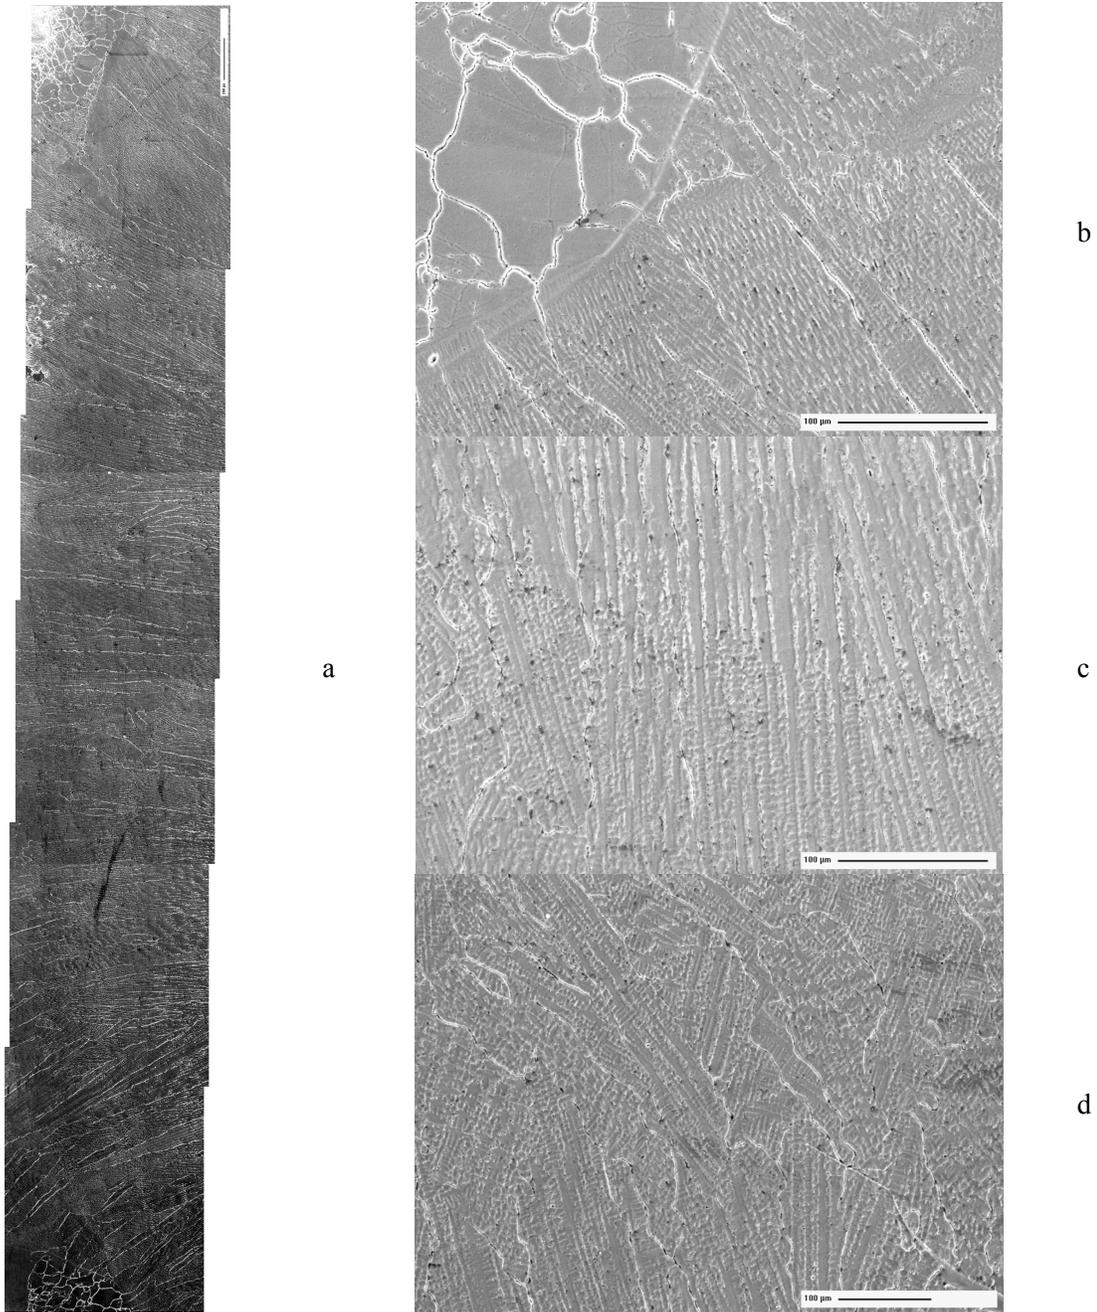
Figure 67. (a) Weld microstructure from Sample 1 (rotated 90° with respect to Fig. 9); (b) transition area between the weld and Alloy 600; and (c,d) dendritic microstructure in the weld.

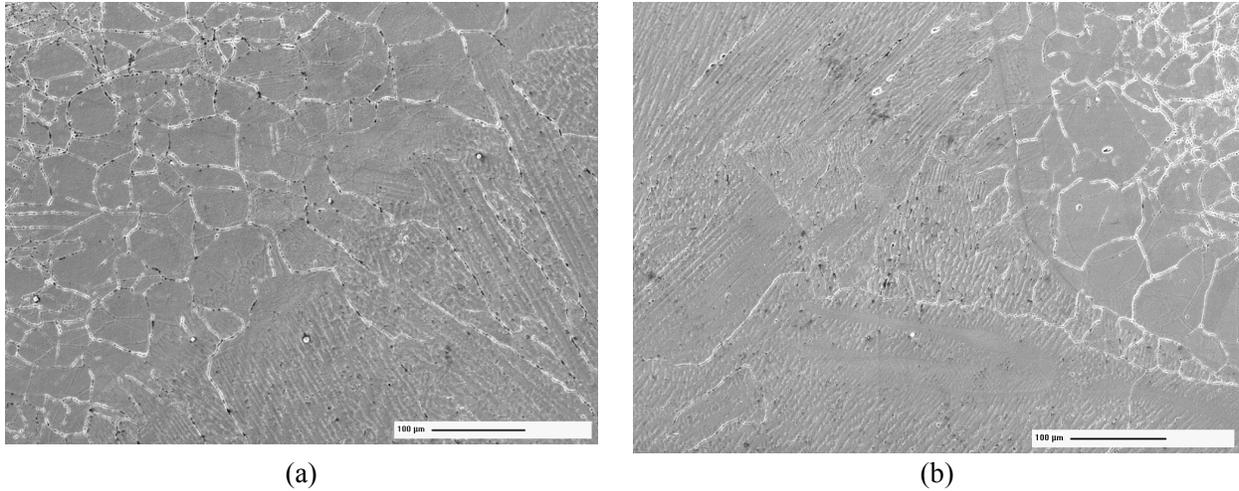
Figure 68. Large grain microstructure in the HAZ at two opposite positions (a and b).

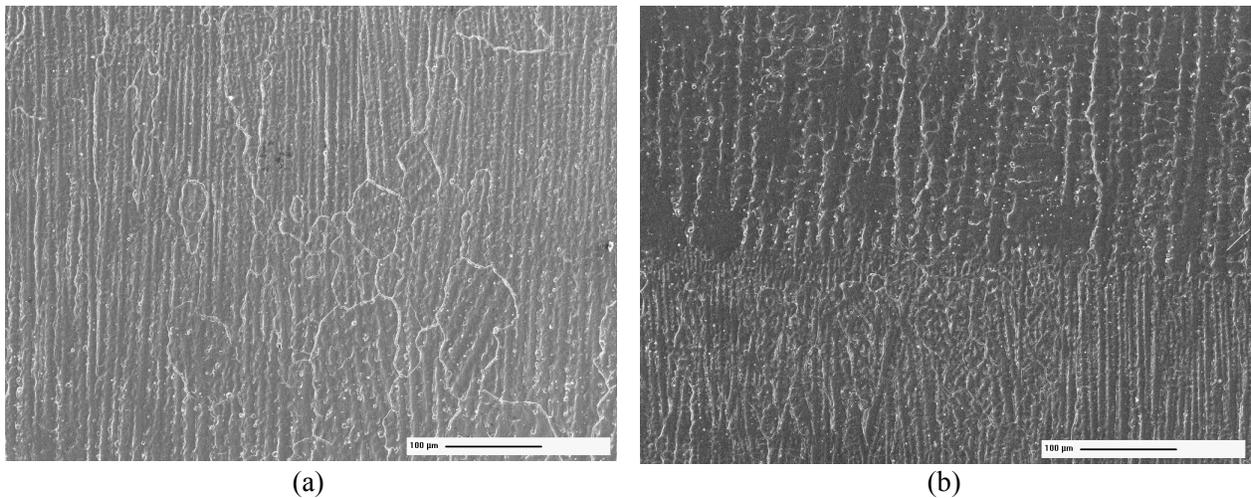
Figure 69. (a) Dendritic microstructure on sample 3A, and (b) at a weld pass.

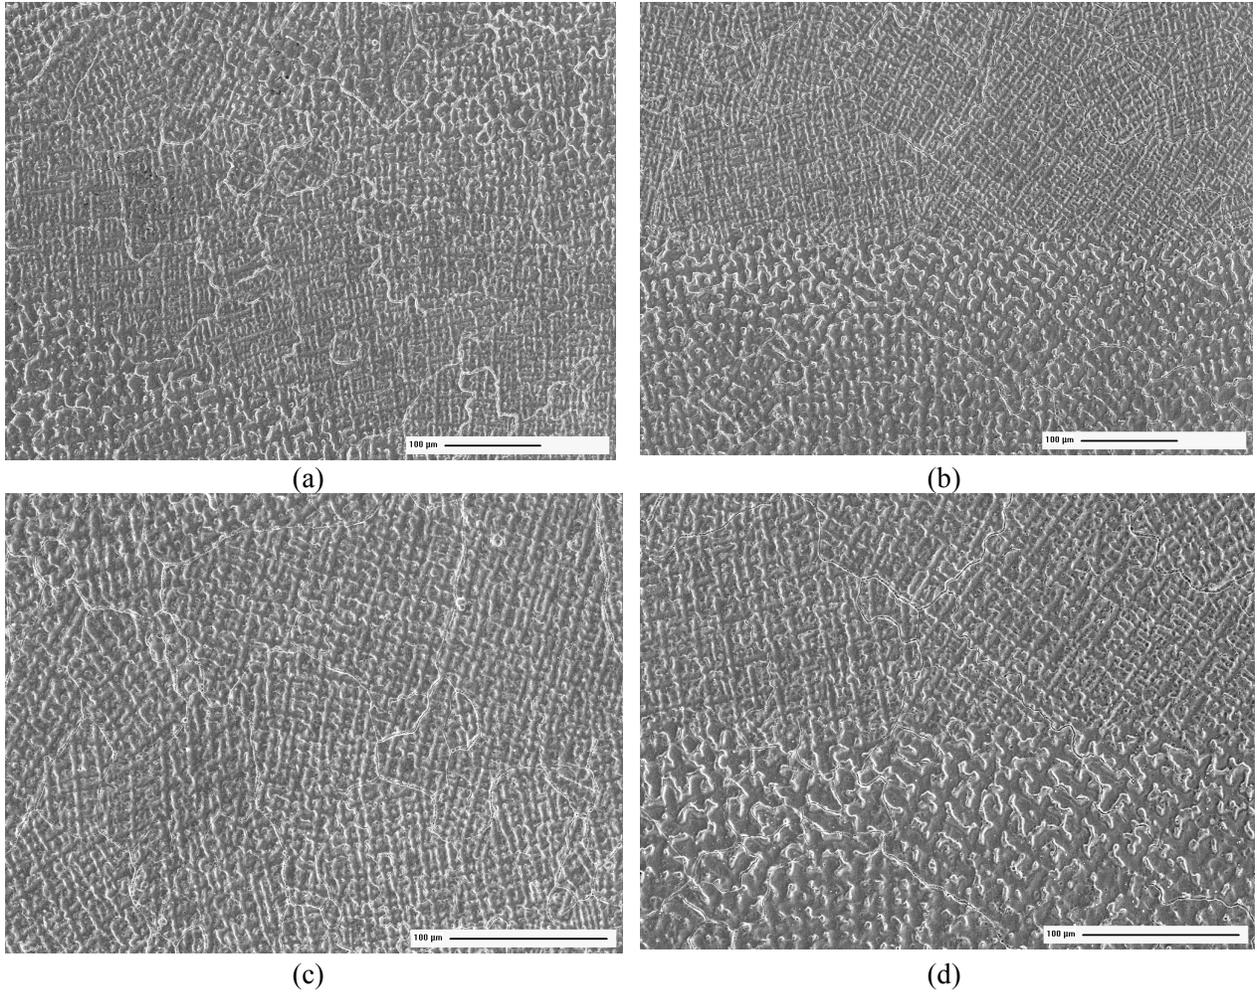
Figure 70. Examples of dendritic microstructure at a weld passes on sample 3B (a,b) and high magnification micrographs at the respective locations (c,d).

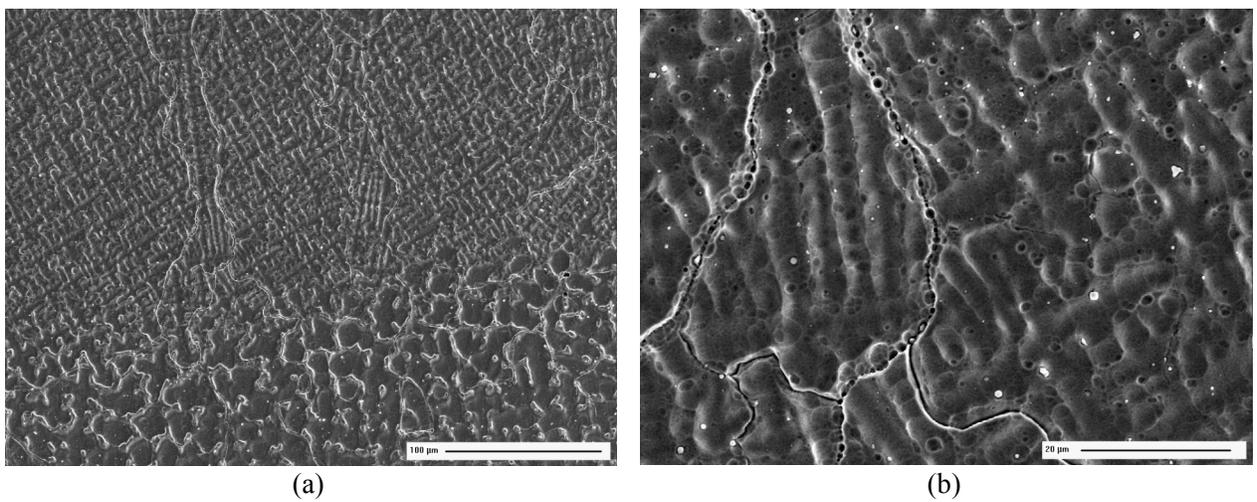
Figure 71. (a) Dendritic microstructure on sample 3B and (b) high magnification of a region from (a).

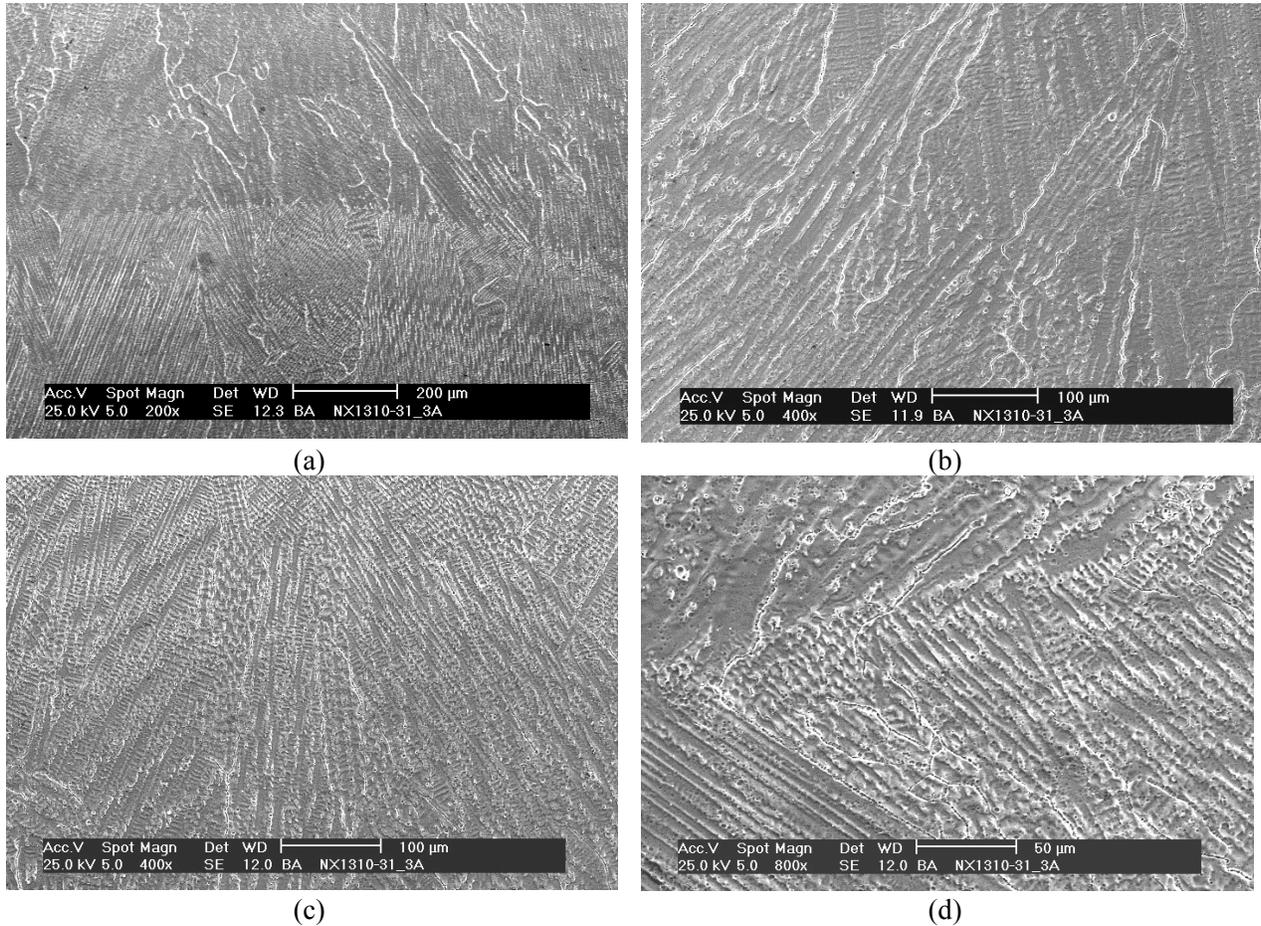
Figure 72. Dendritic microstructure observed on the surface of sample 3A at (a) 200 $\times$ , (b,c) 200 $\times$ , and (d) 800 $\times$  magnifications.

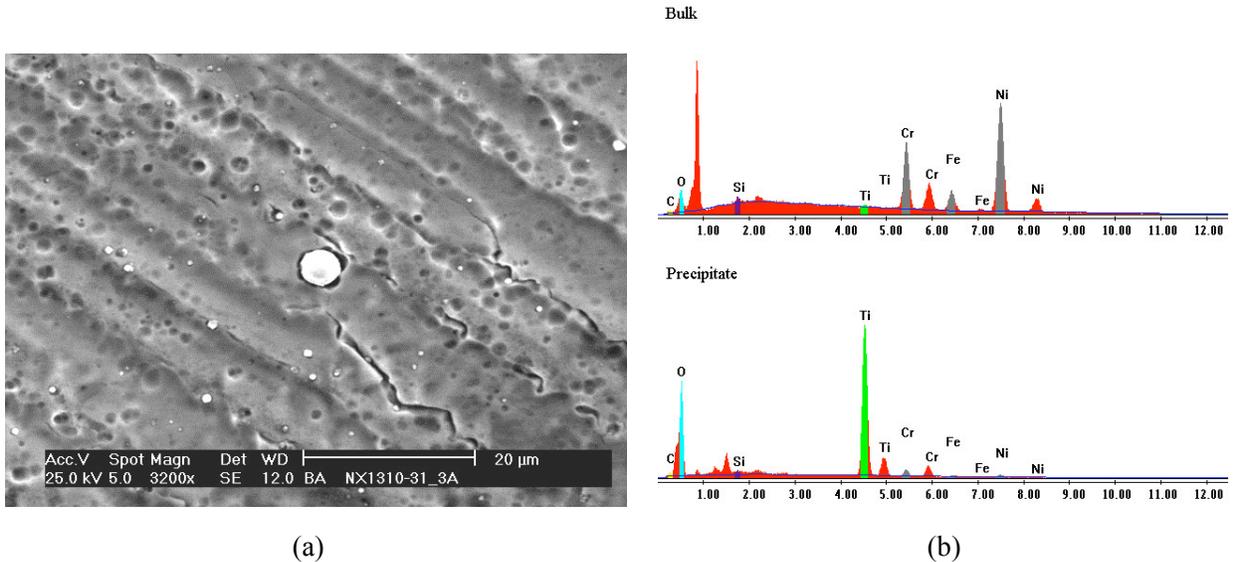
Figure 73. (a) Micrograph showing one of the matrix precipitates observed on the surface of sample 3A and (b) EDX spectra resulting from the bulk and the precipitate shown in (a).

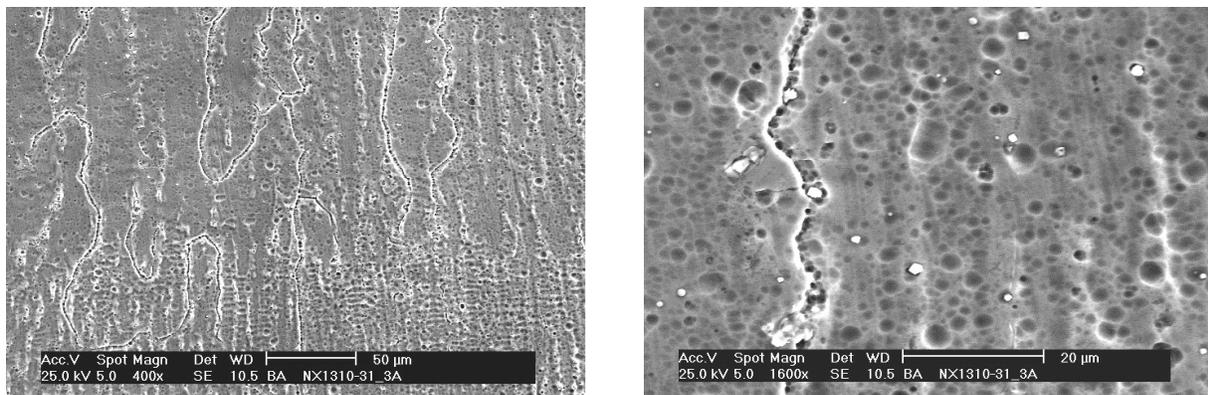
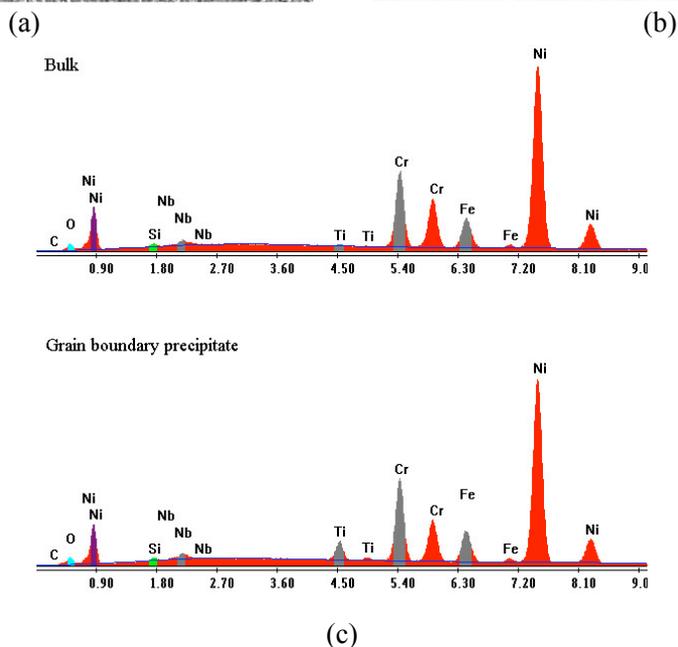
Figure 74. Micrographs showing (a) the microstructure on plane 3A, and (b) matrix and grain boundary precipitates, and (c) EDX spectra resulting from the bulk and from the grain boundary precipitate shown in (b).

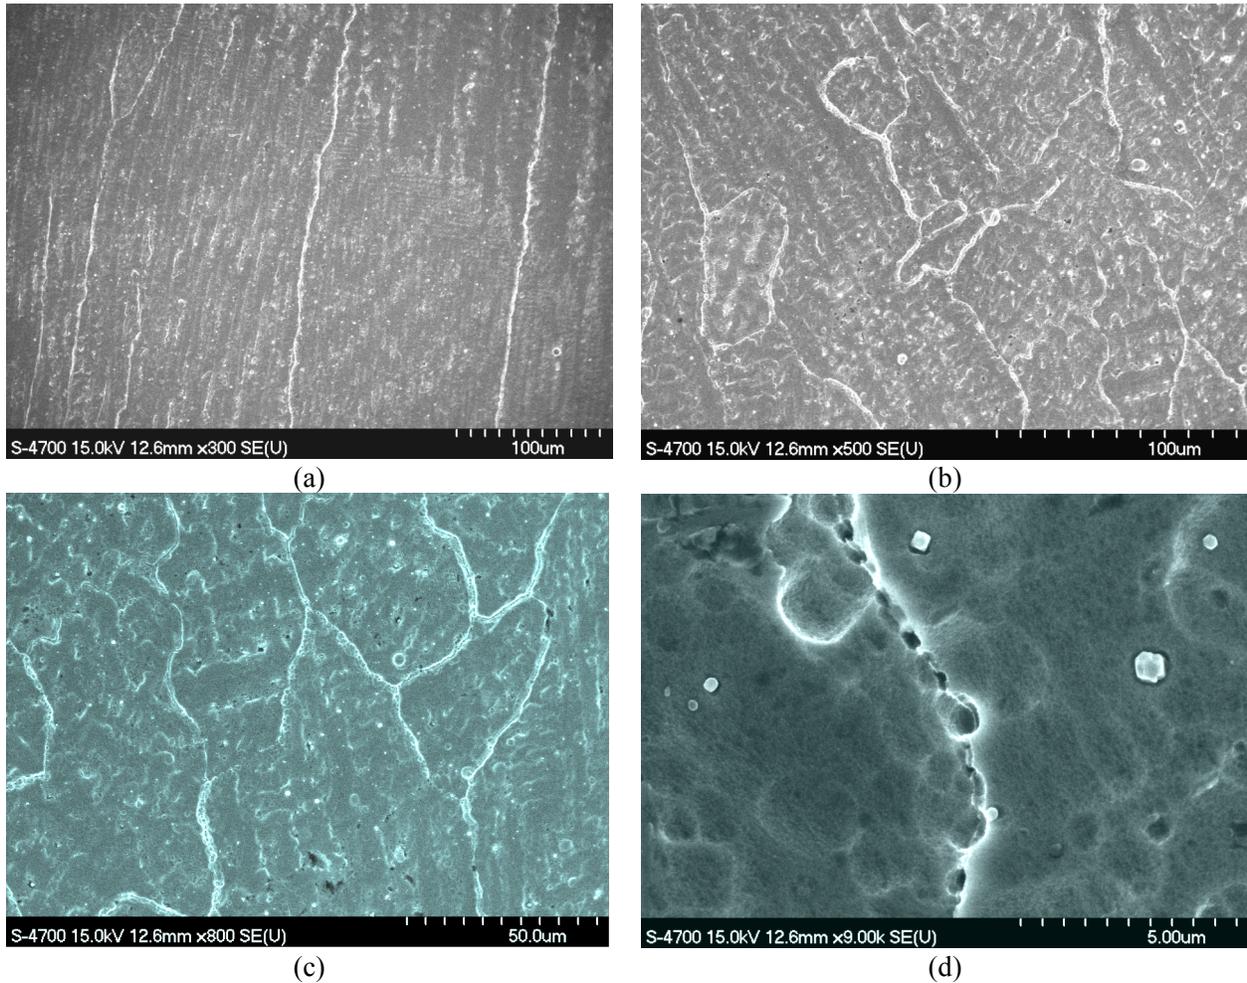
Figure 75. Dendritic microstructure observed on the surface of sample 3A at (a) 300 $\times$ , (b) 500 $\times$ , (c) 800 $\times$ , and (d) 9,000 $\times$  magnification.

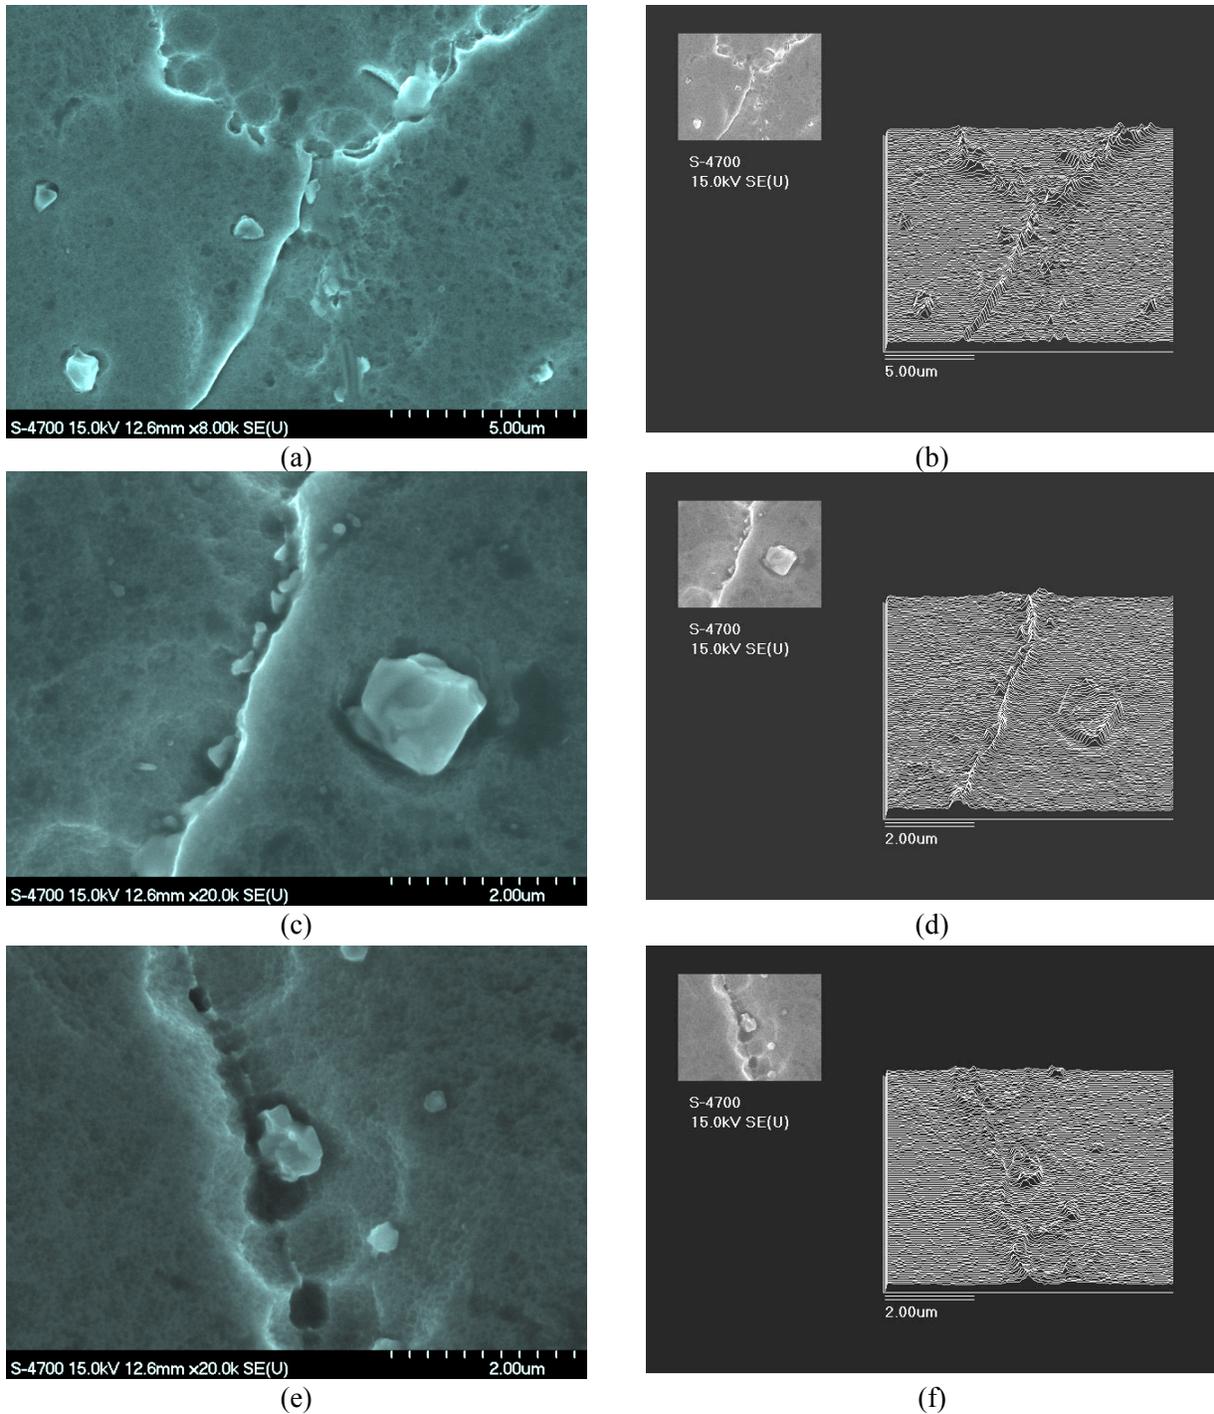
Figure 76. Micrographs showing Ti-rich precipitates in the weld material (a,c,e), and maps showing the topography at the locations where the high magnification micrographs were taken (b,d,f).
