# Environmentally Assisted Cracking in Light Water Reactors

Annual Report  
January—December 2003

Prepared by  
B. Alexandreanu, O. K. Chopra, H. M. Chung,  
E. E. Gruber, and W. J. Shack

Argonne National Laboratory  
9700 South Cass Avenue  
Argonne, IL 60439

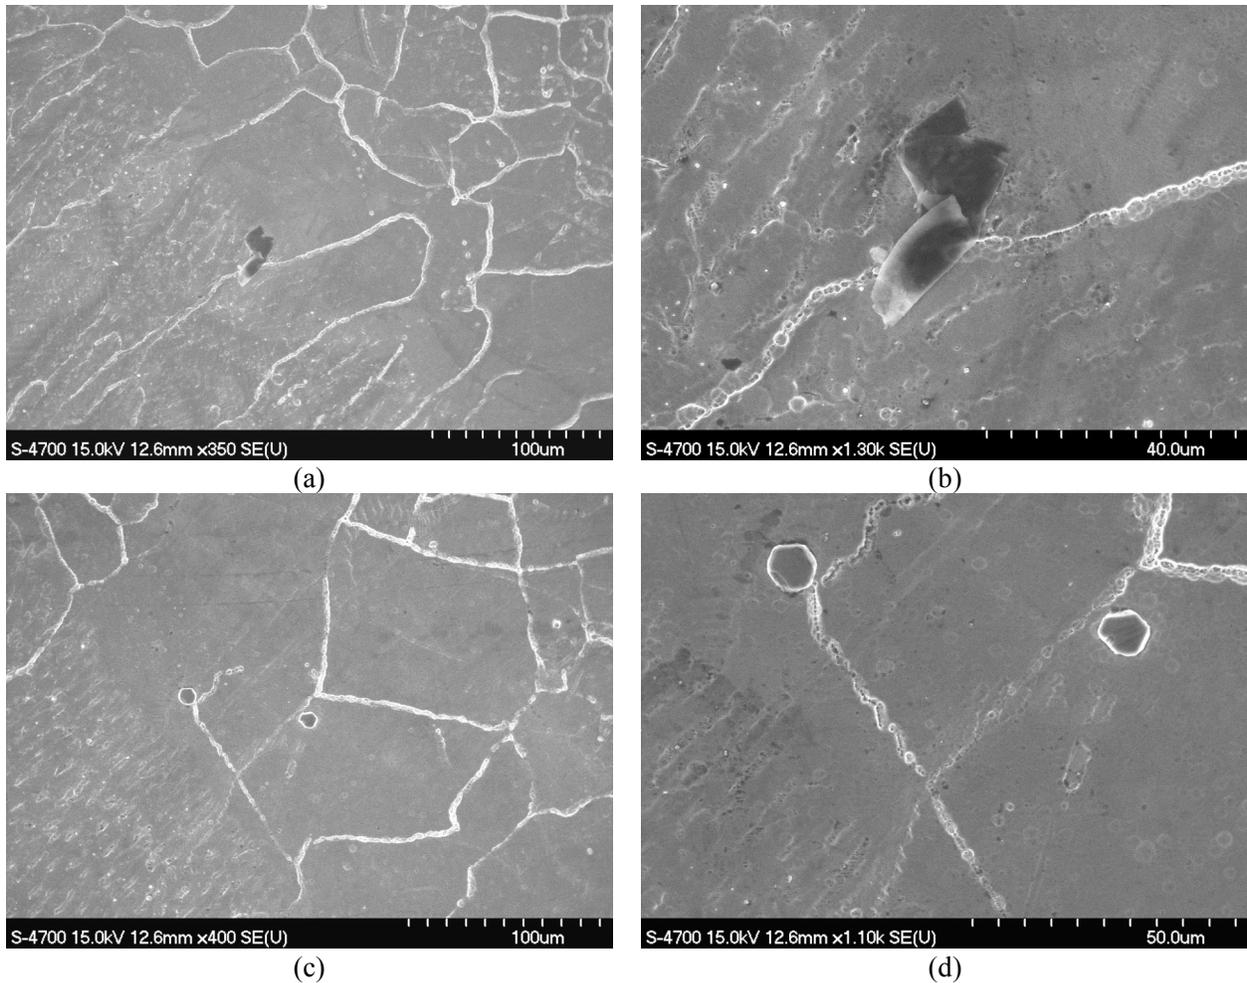
Figure 77. Micrographs showing the heat affected zone (a,c), and high magnification micrographs showing precipitates in the heat affected zone (b,d).

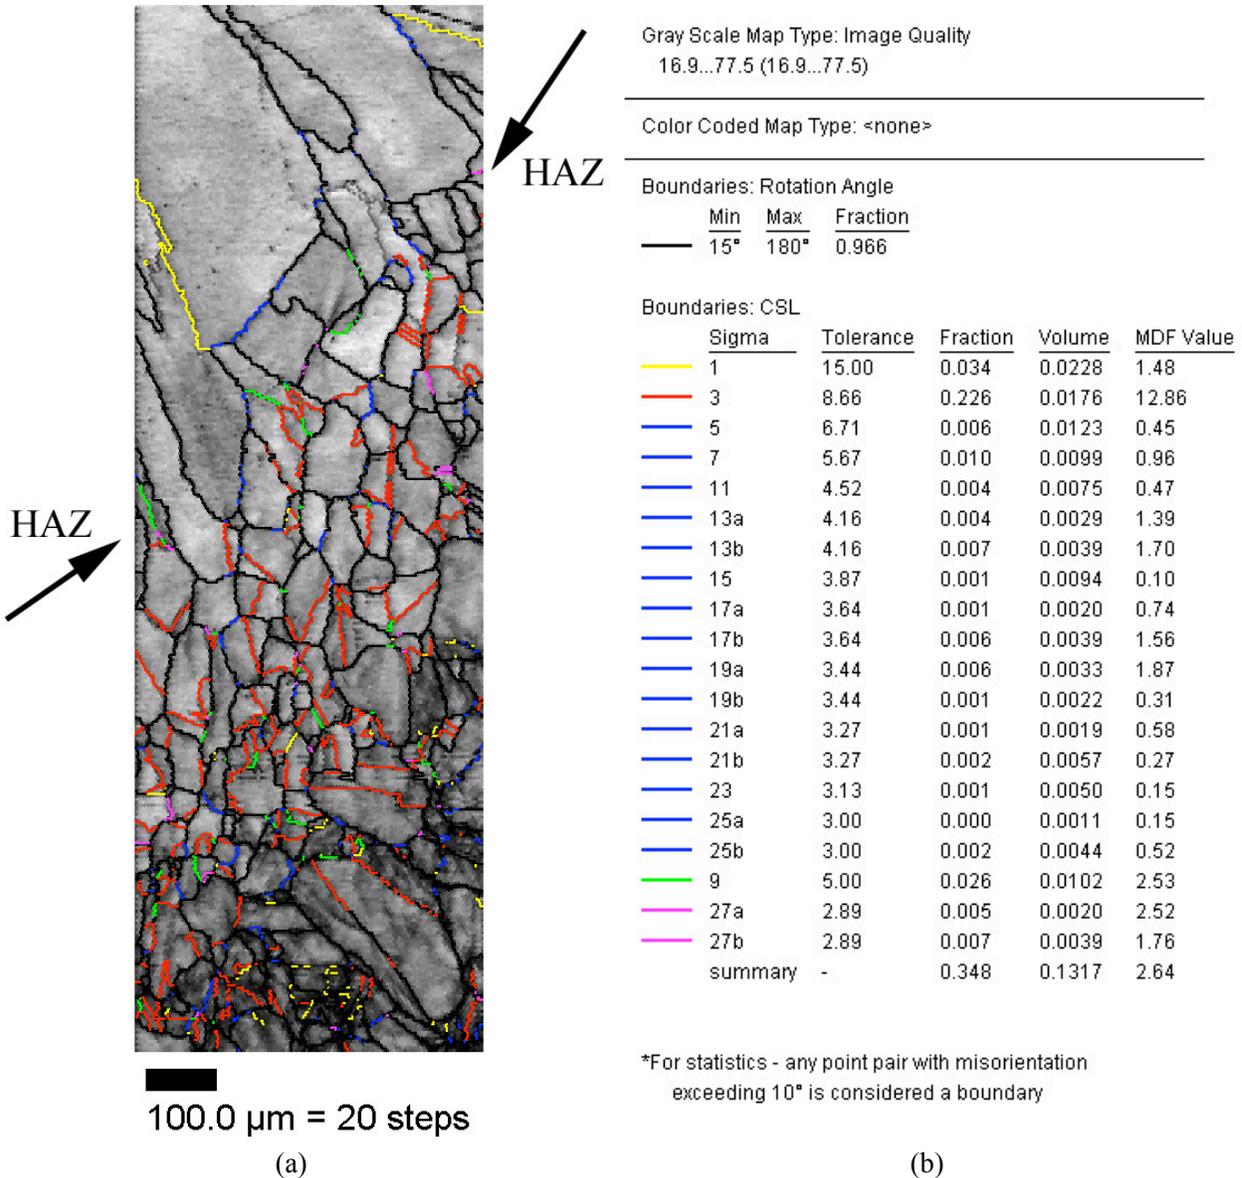
Figure 79. (a) OIM map on the surface of sample 3B and (b) the resulting grain boundary character distribution. The OIM map covers the weld (upper part), the HAZ (indicated by arrows), and Alloy 600 (lower part).

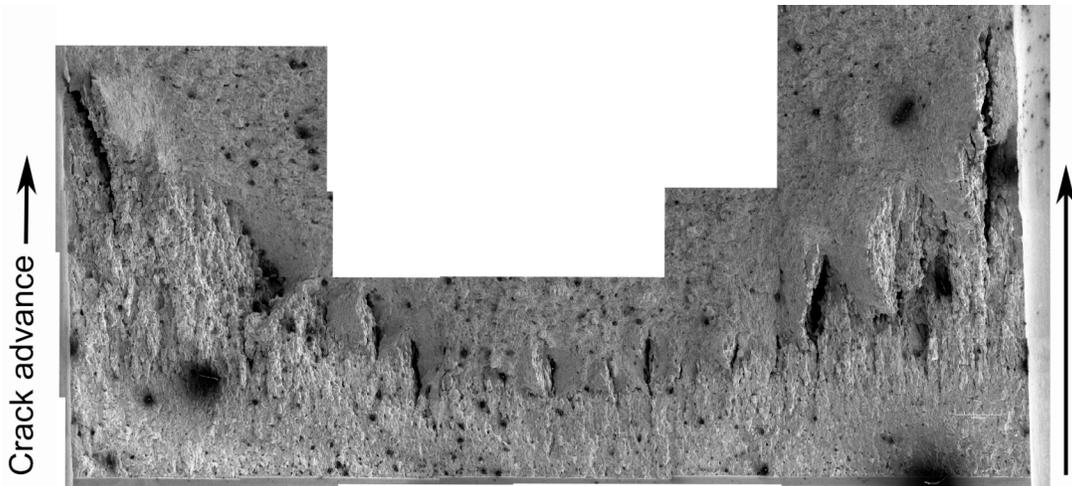
Figure 83. Entire crack surface of Alloy 600 round robin specimen RR-1 tested in PWR water at 320°C.

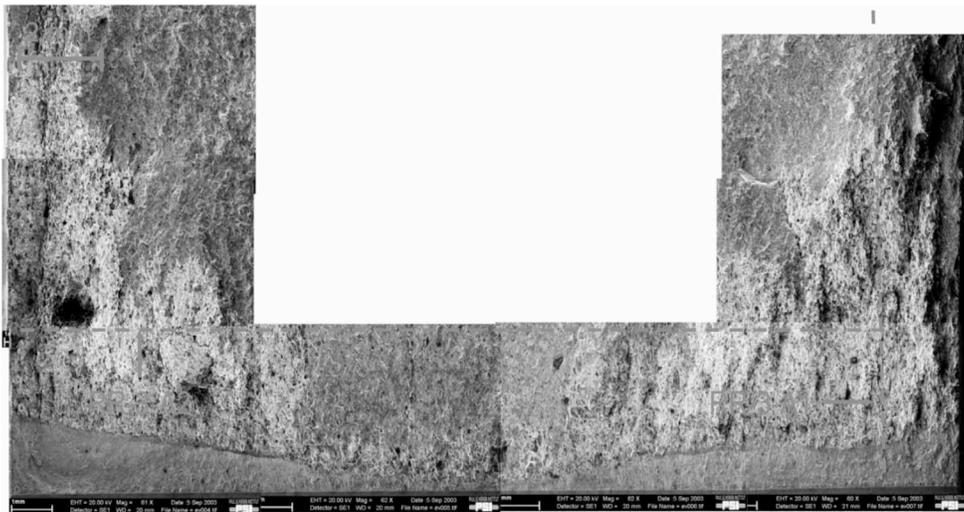
Figure 84. Entire crack surface of Alloy 600 round robin specimen RR-3 tested in PWR water at 320°C.

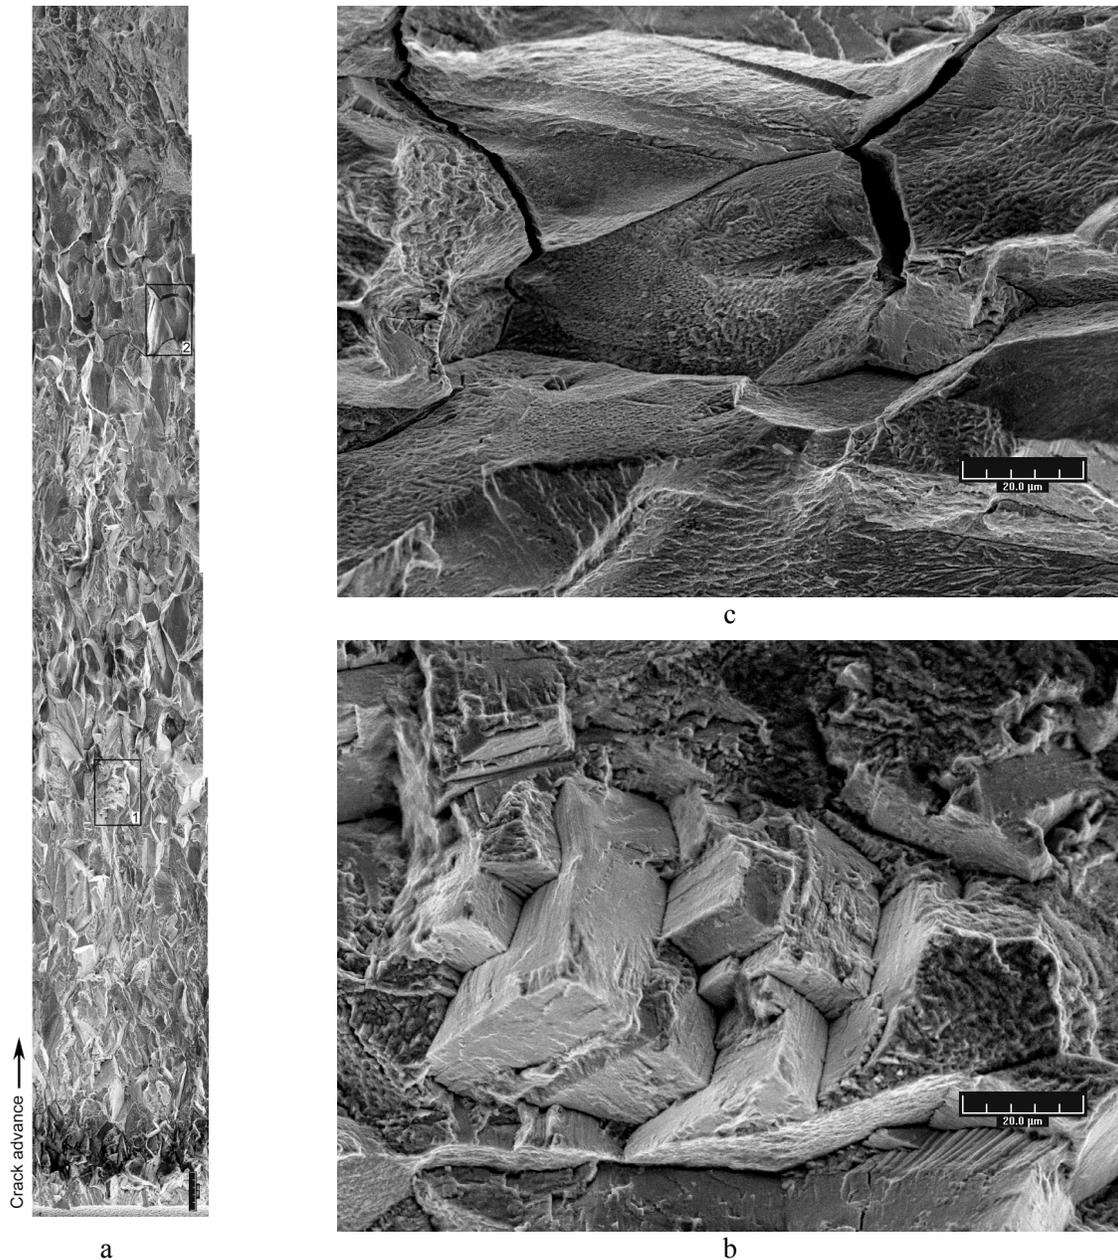
Figure 85. (a) Selected portion of the crack surface of Alloy 600 round robin specimen RR-1 tested in PWR water at 320°C showing the changes in fracture morphology, and (b,c) micrographs taken at the boxed positions 1 and 2, respectively, in (a).

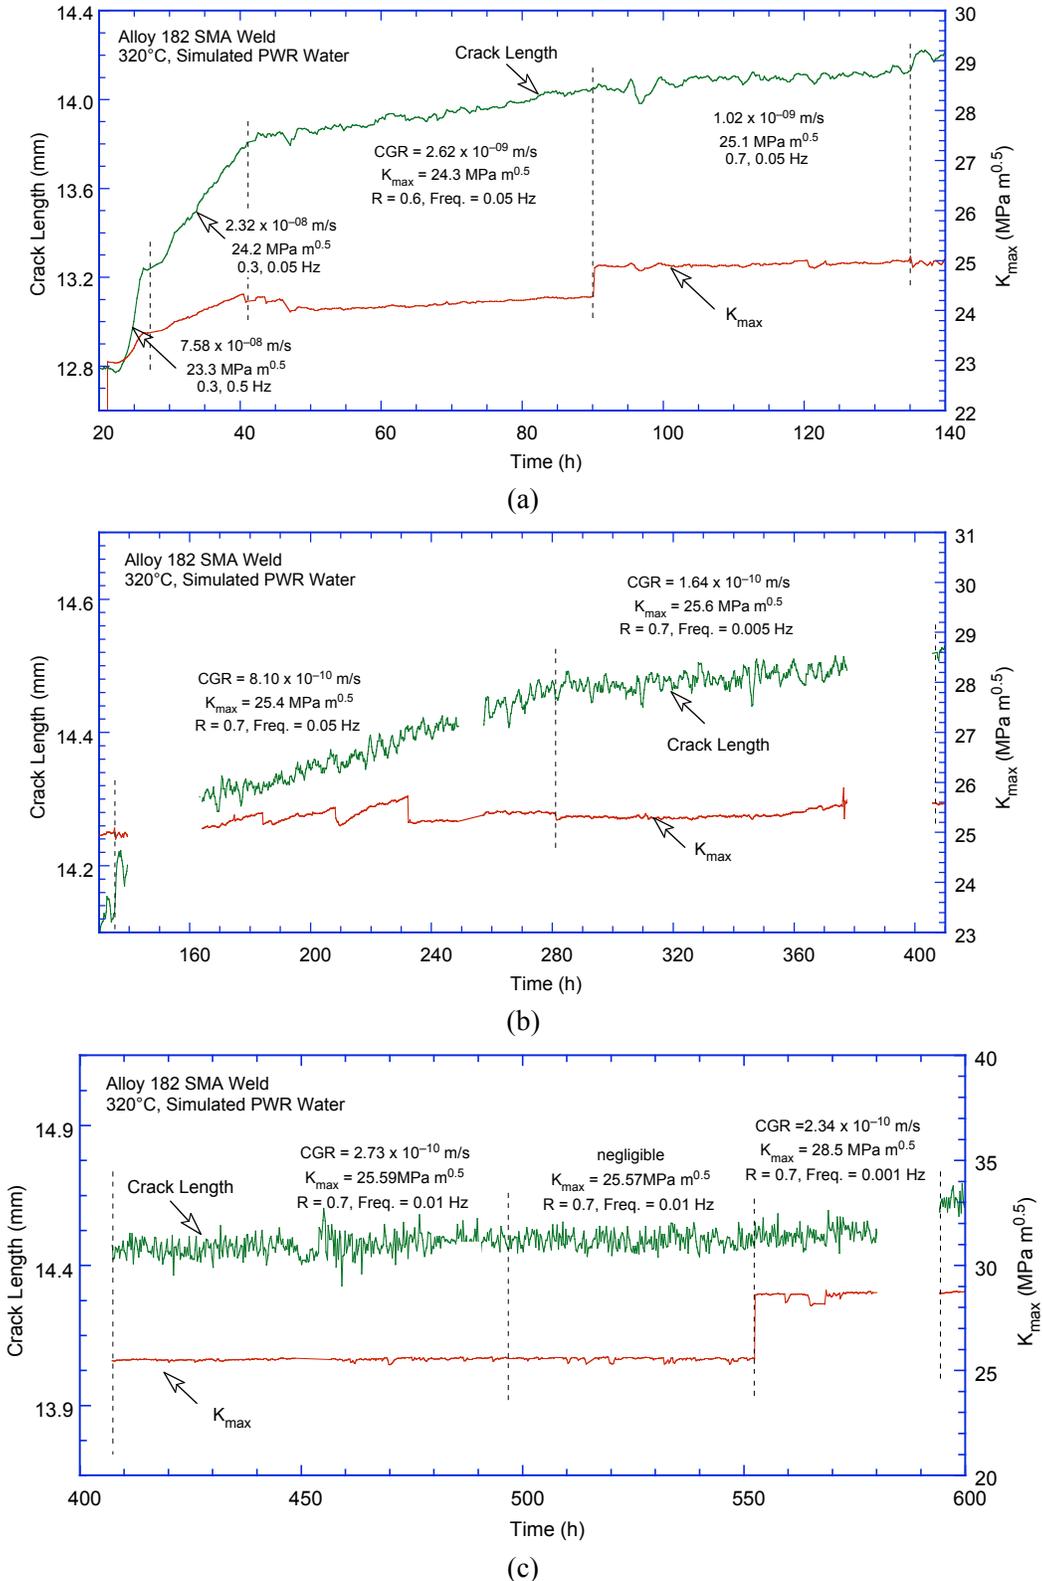
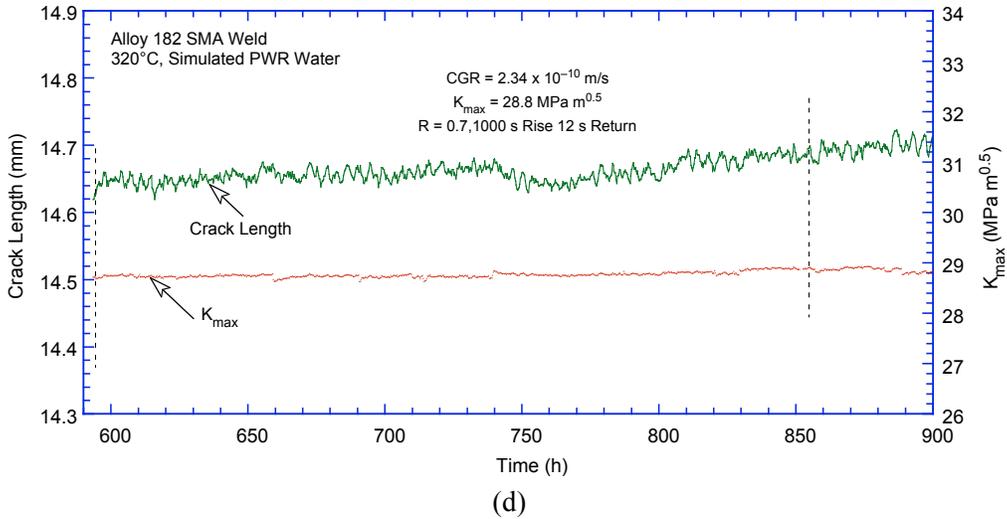
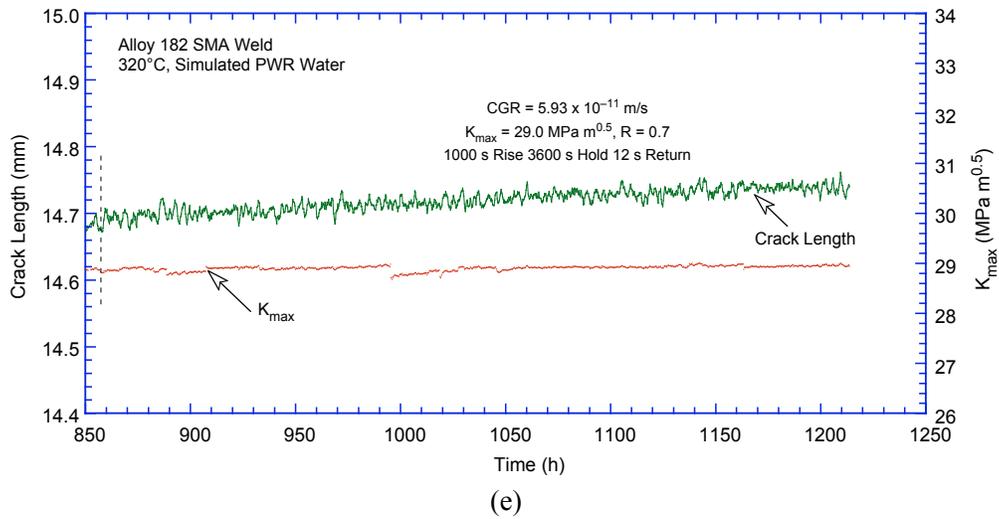
Figure 86. Crack length vs. time plot for Alloy 182 SMA weld-metal specimen in simulated PWR environment at 320°C during test periods (a) 1-4a, (b) 4b-5, (c) 6-8, (d) 9, and (e) 10.

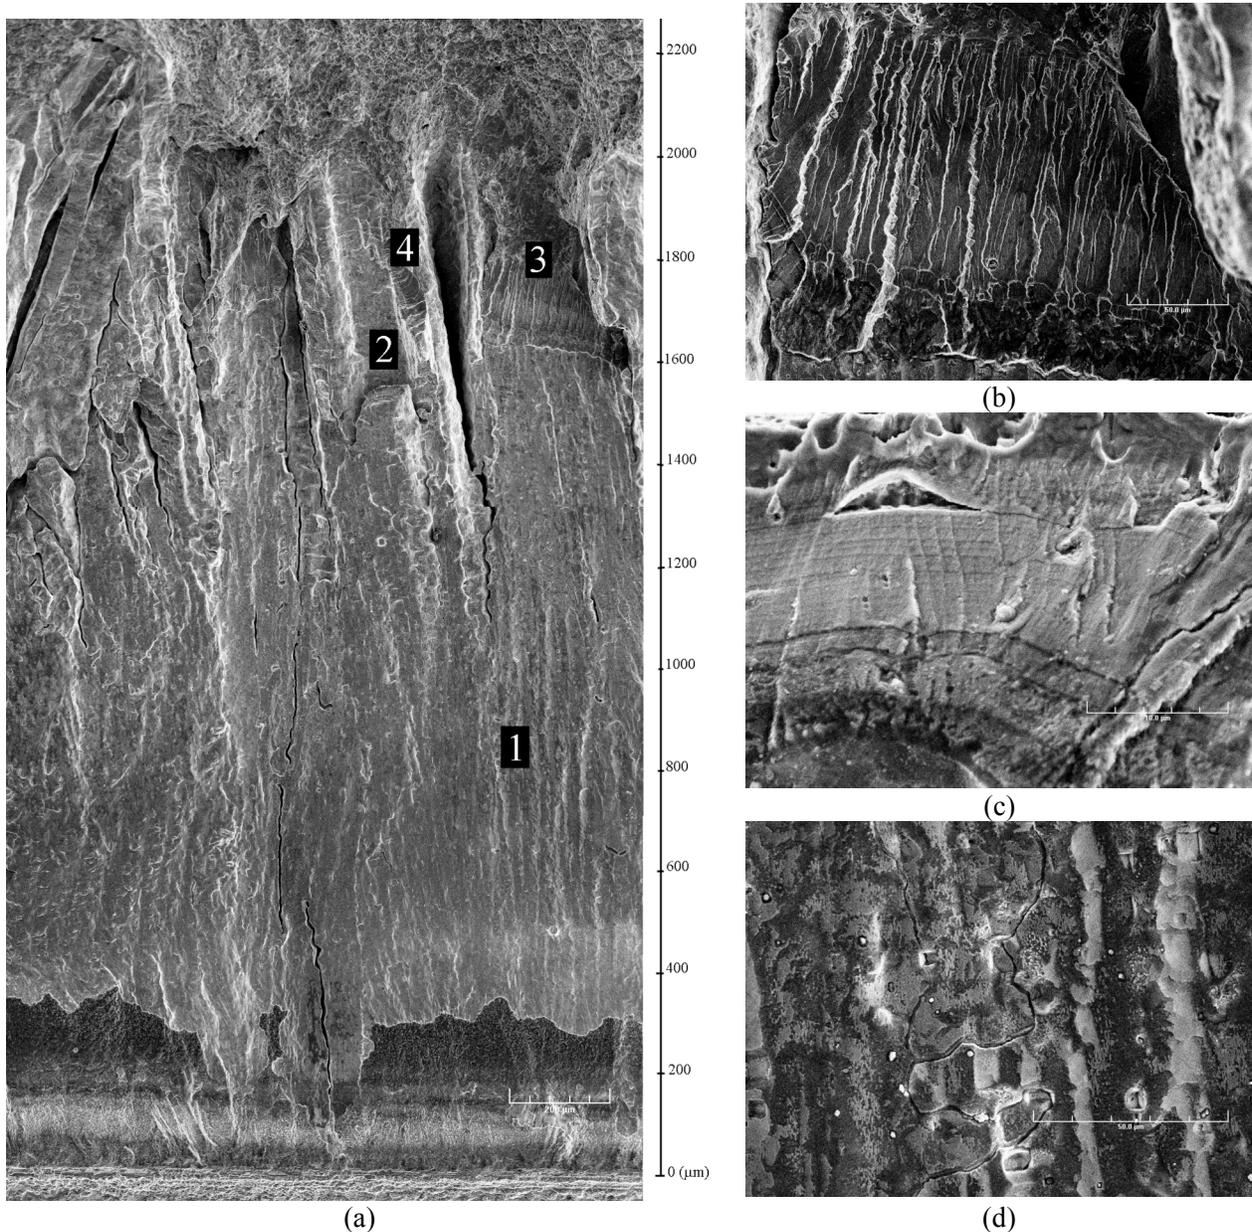
Figure 88. A higher magnification photomicrograph showing entire crack extension in a region in the center of the specimen.

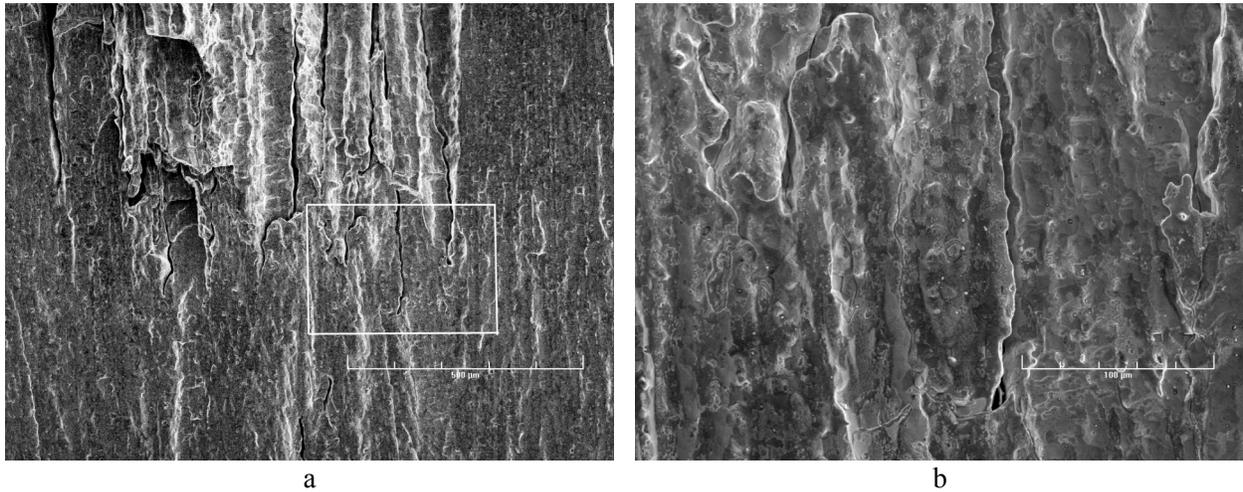
Figure 89. (a) Transition from TG to IG fracture and (b) higher magnification micrograph of the boxed area showing the tip of a few cracks.

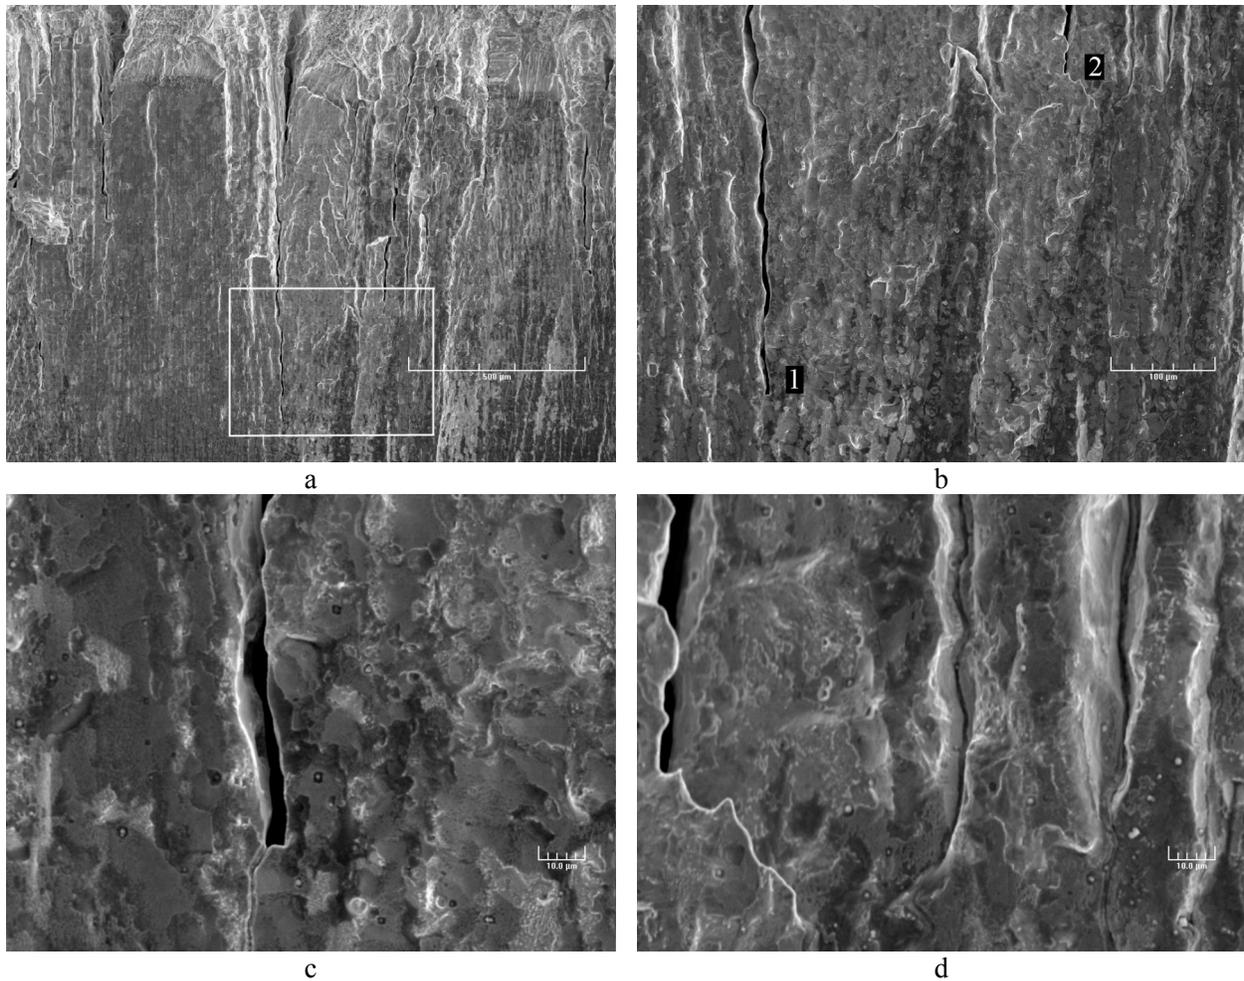
Figure 90. (a) Mixed TG and IG fracture modes, (b) high magnification micrograph of the boxed area, and (c,d) micrographs showing the crack tips at locations “1” and “2.”

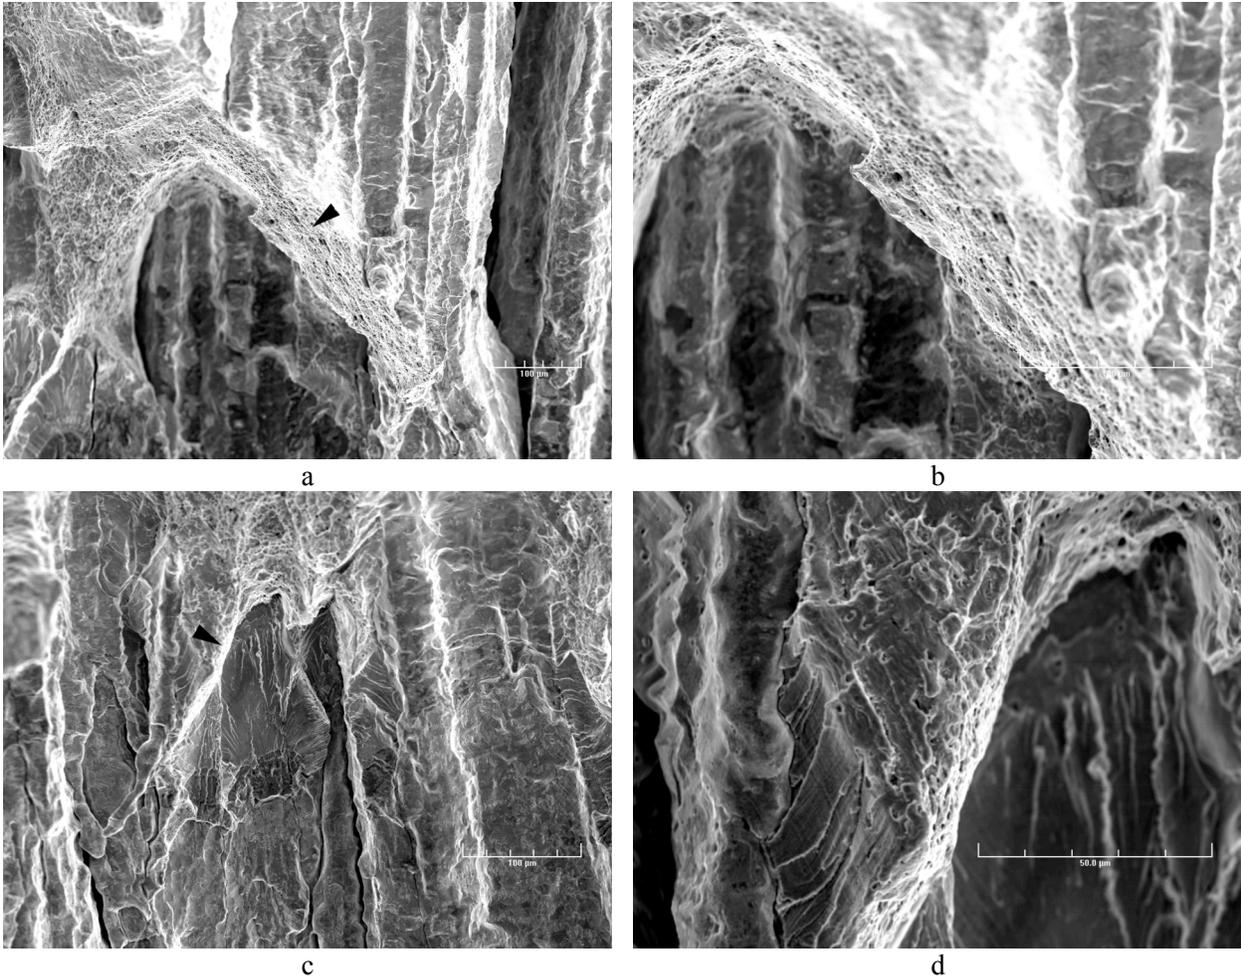
Figure 91. (a,c) Photomicrographs detailing the fracture in a region during test periods with a hold time and/or a high rise time, and (b,d) high magnification micrographs of positions indicated by arrows.

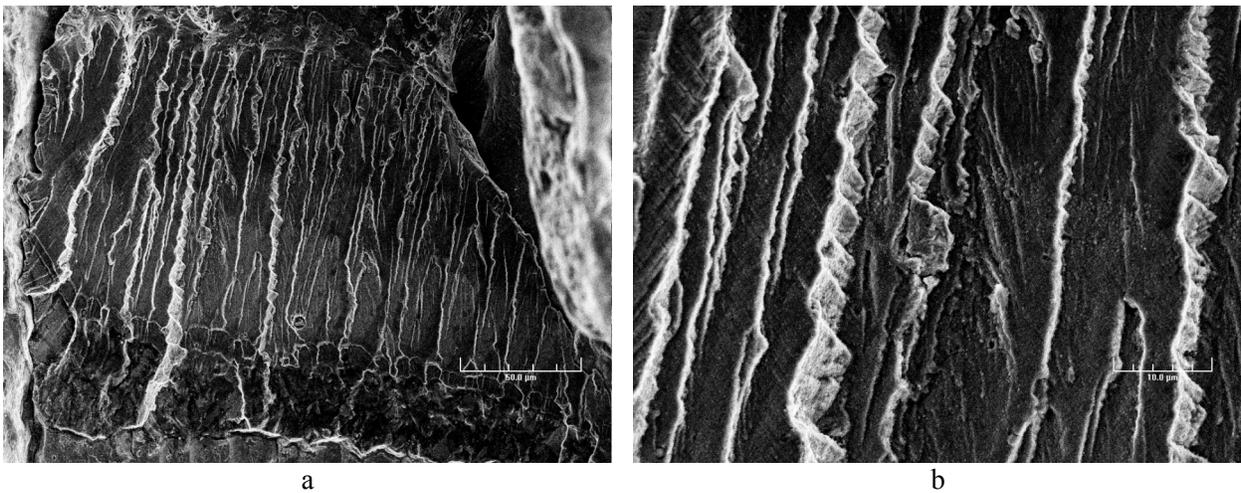
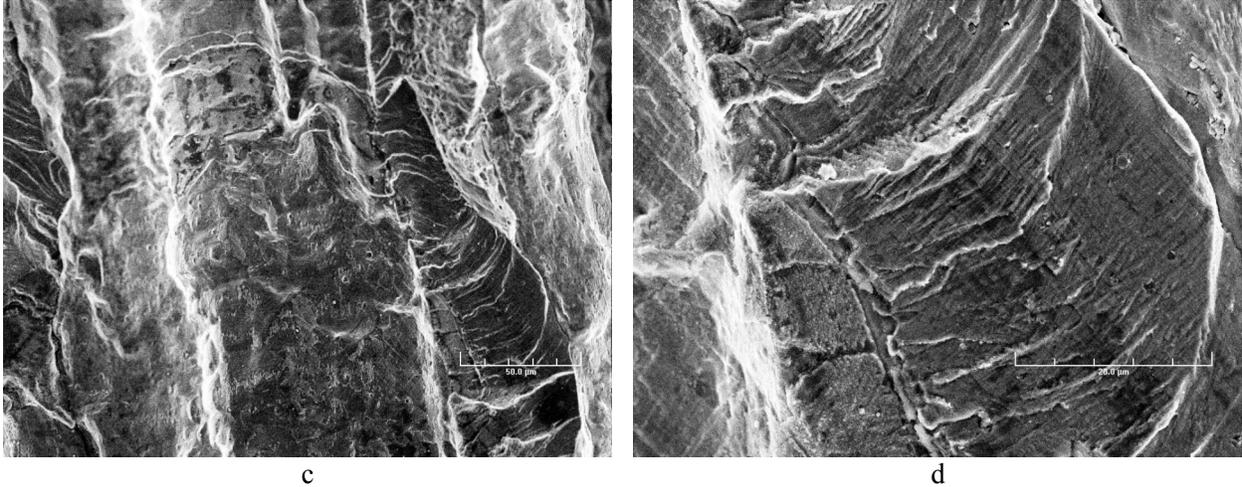
Figure 92. (a,c) Photomicrographs detailing the fracture in a region during test periods with a hold time and/or a high rise time, and (b,d) high magnification micrographs.
